VST Operation Number	Description
98494-2	Screw engine pad replace acc. to TJ33442

SPA – Left engine pad click sound

TJ33442

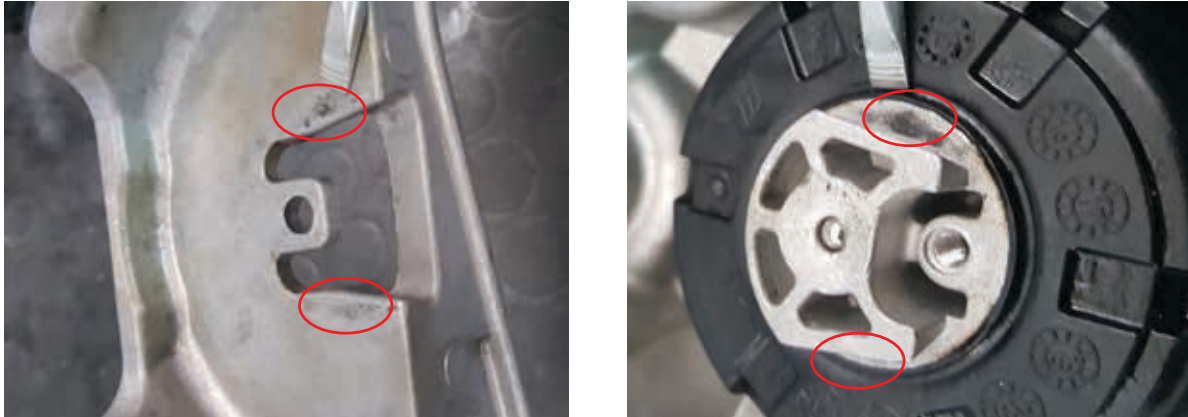
If the vehicle has a click sound from the left engine pad during driving, (a metallic click sound from A-pillar area)

Separate the engine pad and lubricate with graphite (see attachment), then follow instruction new screw and washer.

Torque 10 NM.

Put lubricating grease with graphite on red marked points as in pictures above.
