Leather dashboard, leather comes loose

REF NO: TJ 29012.6.0	ISSUING DEPARTMENT: Technical Service	CAR MARKET: United States and Canada		
3 US 7	PARTNER: '510 Volvo Car USA	ISSUE DATE: 2020-10-02	STATUS DATE: 2020-10-09	
FUNC GROUP: 8811	FUNC DESC: Instrument panel	Page	1 of 3

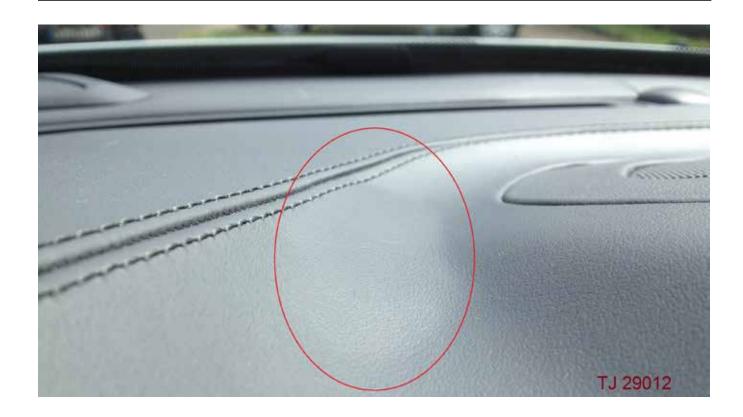
Leather on dashboard may come loose on small areas.

In case of customer complaints regarding leather coming loose from the dashboard, complete dashboard must be replaced.
