SIB 51 26 20

SERVICE ACTION: CHECK REAR WINDOW

E-Series	Model Description	Production Date
G20	3 Series Sedan	July 13, 2020-September 1, 2020

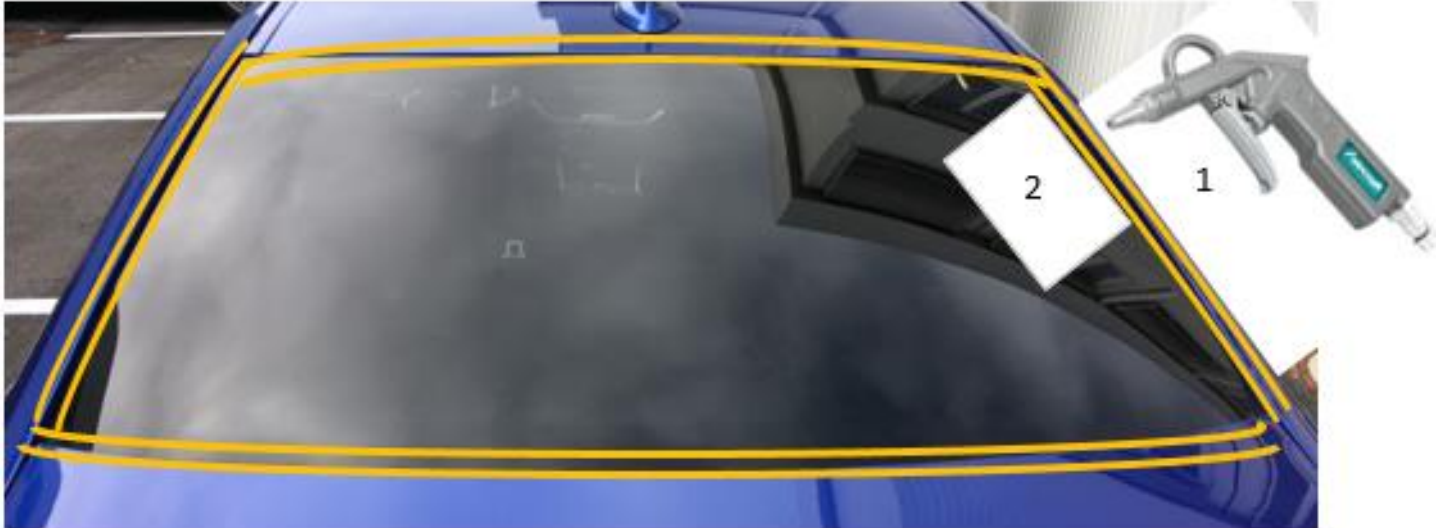
The rear window may not have been properly bonded.

The rear window may not have been properly bonded to the body during production.

1. Using an air blow gun (# 1 below), blow air along the perimeter of the back window (aka rear windshield) towards the inside of the vehicle. Ensure the entire perimeter of the window is checked.

2. While air is being blown around the perimeter, person 2 follows along from the inside of the vehicle, moving along the back window perimeter with a piece of paper (#2 above). Movement of the paper caused by air entry indicates a leakage.

3. Re-bond the rear window following repair instructions **REP 51 31 200 “Removing and installing rear window”**.
