SIM 64 02 20

2020-10-26

CONDENSATION FROM AIR CONDITIONING LEAKS INTO PASSENGER FOOTWELL

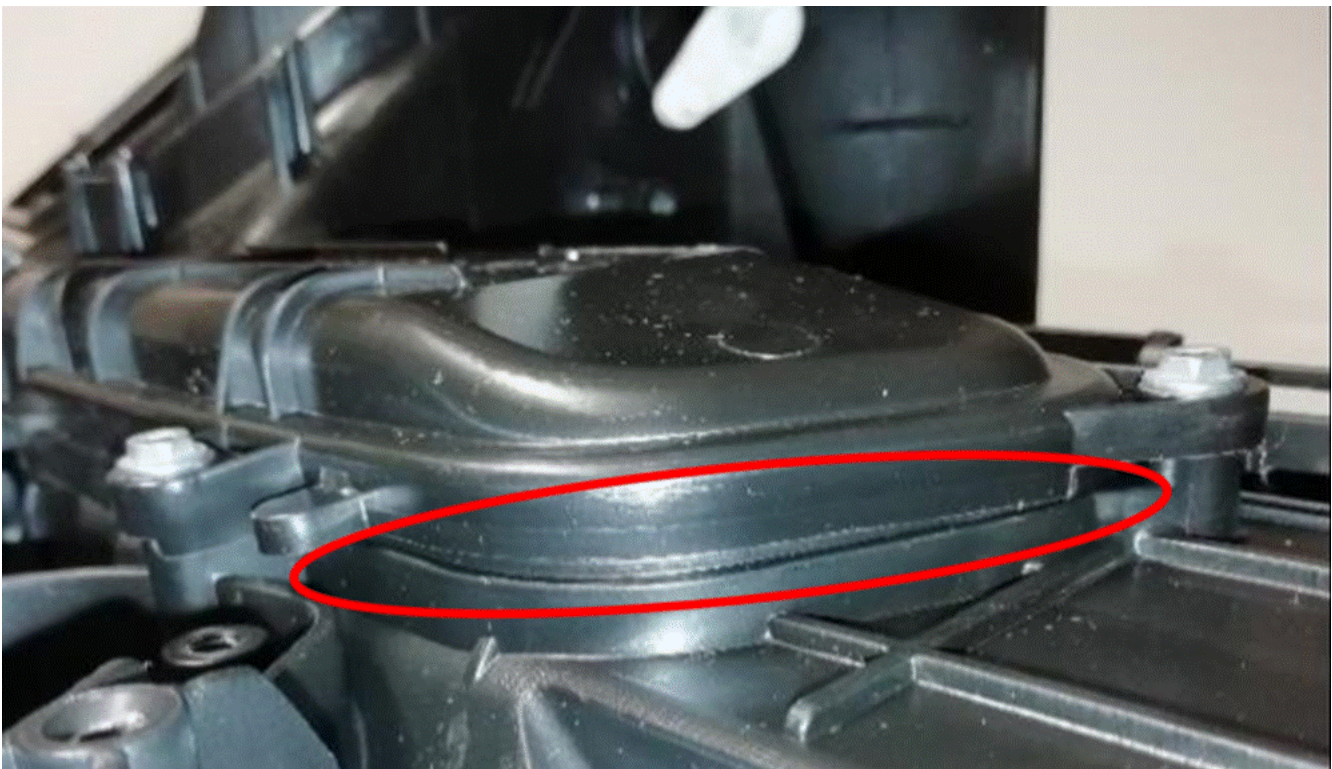
During assembly, the cover of the fresh air intake was not fully seated when the screws were tightened.

This cover can then leak condensation out through the existing gap

Remove, correctly position and reinstall the fresh air intake cover
