## STAR ONLINE PUBLICATION

**Case Number:** S1923000014 Rev C

**Symptom/Vehicle Issue:** Ram Box Lid Fitment And Or Closing Effort Issues

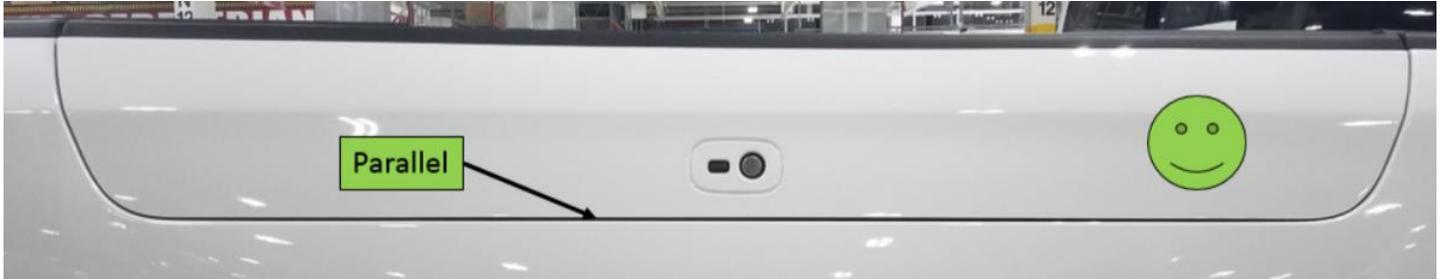
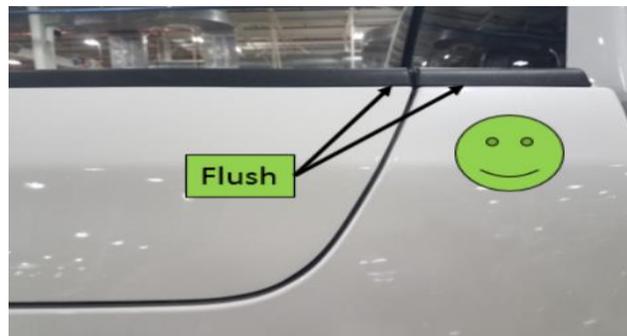
**Discussion:** Lid fitment issues can be improved with adjustments. Visually inspect and test operate the lids to confirm an issue. The bed to Ram Box gaps should be even. The lid top should be flush to the bedside. If not- follow the steps below to adjust. Acceptable gaps and fitment:

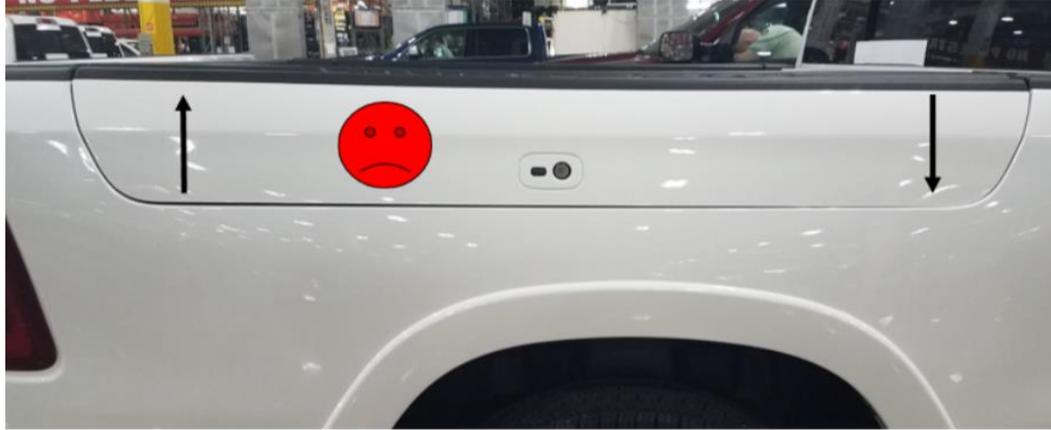
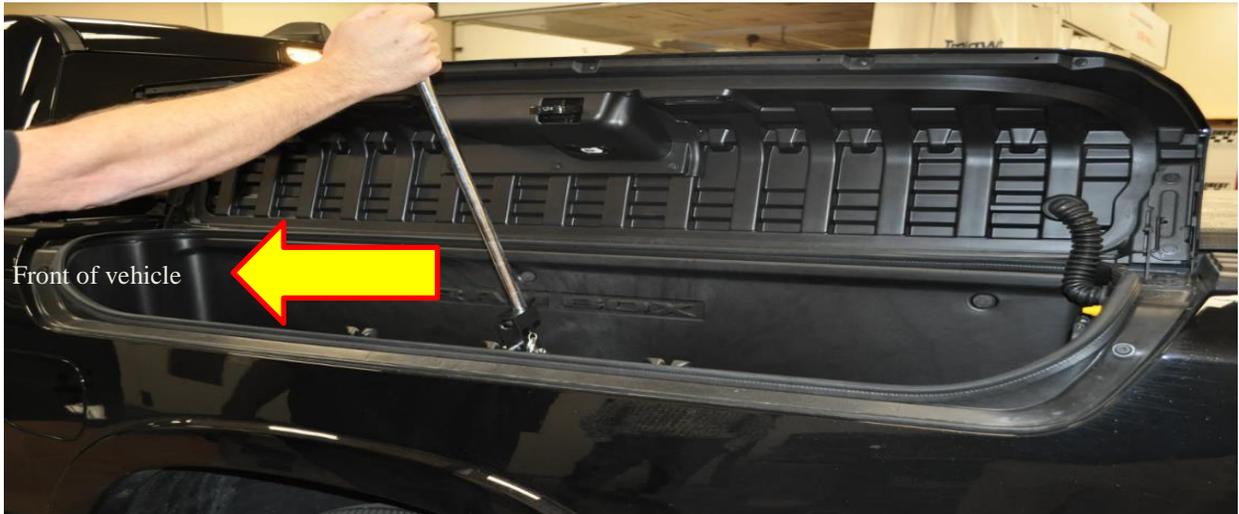
1. Uneven gaps at bottom of lid.

If the gap is higher at the REAR, open the lid and carefully use a MOPAR essential tool 2069900230 to bend the striker forward (toward front of the vehicle).

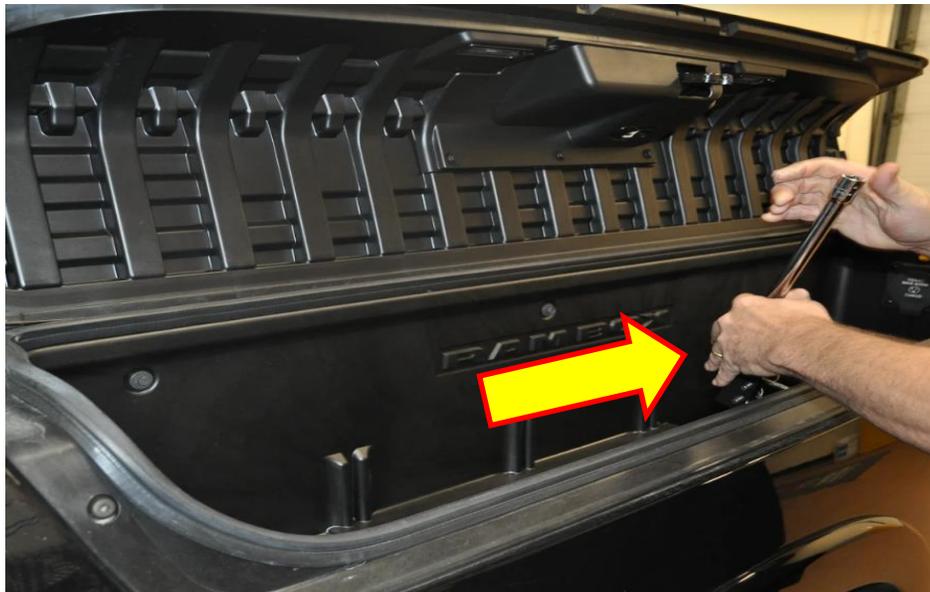
Bending rearward

If the gap is higher at the FRONT, open the lid, and apply force to the tool to bend the striker loop rearward.

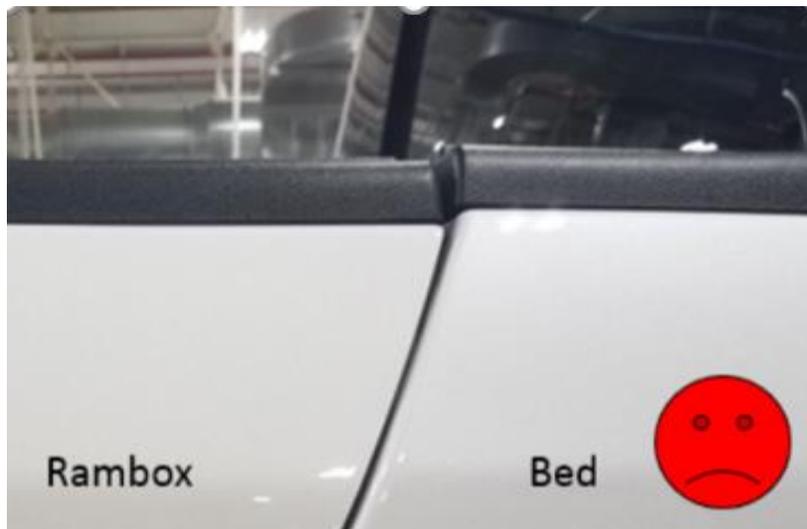
Under flush condition

After adjusting the lid parallel in step 1, if the lid is under flush to the bed trim and/or closing effort is high, open the lid and use pry tool to bend the striker UPWARDS to raise the lid. Over flush requires a striker move DOWNWARDS to lower the lid.

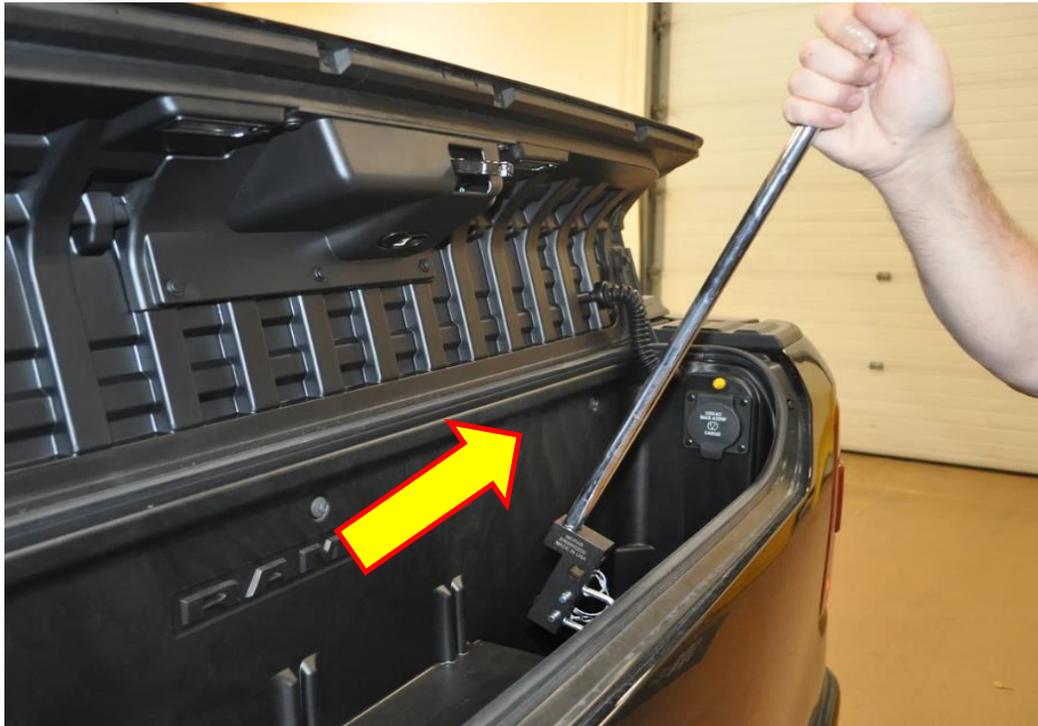
Bending the striker upwards to raise lid.
