STAR ONLINE PUBLICATION

Case Number: S1923000047 Rev A

Symptom/Vehicle Issue: P1D73 AGS (Active Grille Shutter Performance), Malfunction Indicator Lamp (MIL) Illuminated

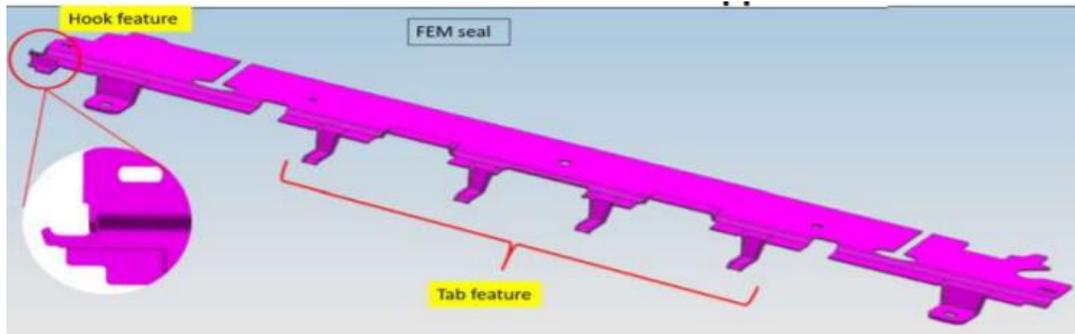
- Front End Module (FEM) seal is causing the Active Grille Shutter (AGS) to bind on gas and diesel vehicles.
- Powertrain Control Module (PCM) software is creating potential false setting of P1D73 code due to a software issue on gas vehicles.

Fig 2. FEM seal attached to mid core support area

1. If the vehicle is built prior to 3/13/19. Replace the Front End Module (FEM) seal with part number 68359231AC or later. See fig. 2. The new FEM mid seal has wire harness clips at the ends and 4 tabs to improve fit and attachment.
