STAR ONLINE PUBLICATION

Case Number: S180800031 REV. A

Symptom/Vehicle Issue: Power Windows, Door Locks, Mirrors, Operate Intermittently, Driver Door Ajar Warning Lamp On, Stop Start Feature Disabled

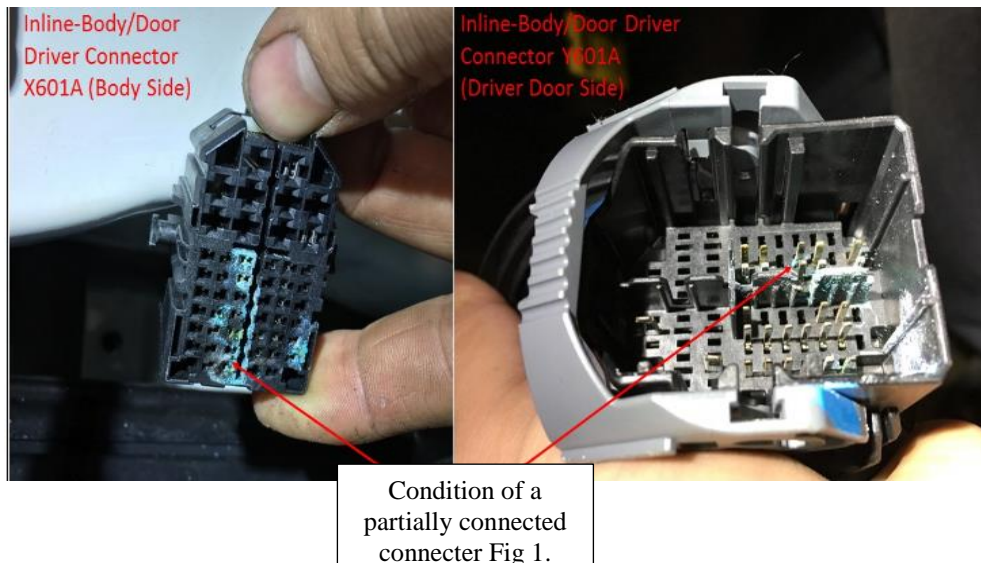
Repair Procedure: DTCs setting may be active or stored. B18B7-24 (Master Switch-Rear left window switch-signal stuck high), B25C9 (Driver Door Ajar Switch 2 Stuck Closed), B180F-15 (Driver Door Ajar-Circuit Short to Battery or Open), and B18CF-15 (Secondary Driver Door Ajar-Circuit Short to Battery or Open). Inspect the driver door/body harness grommets and connector for corrosion. Align grommet for proper sealing, clean and secure connector to complete Fig 1, 2, 3.

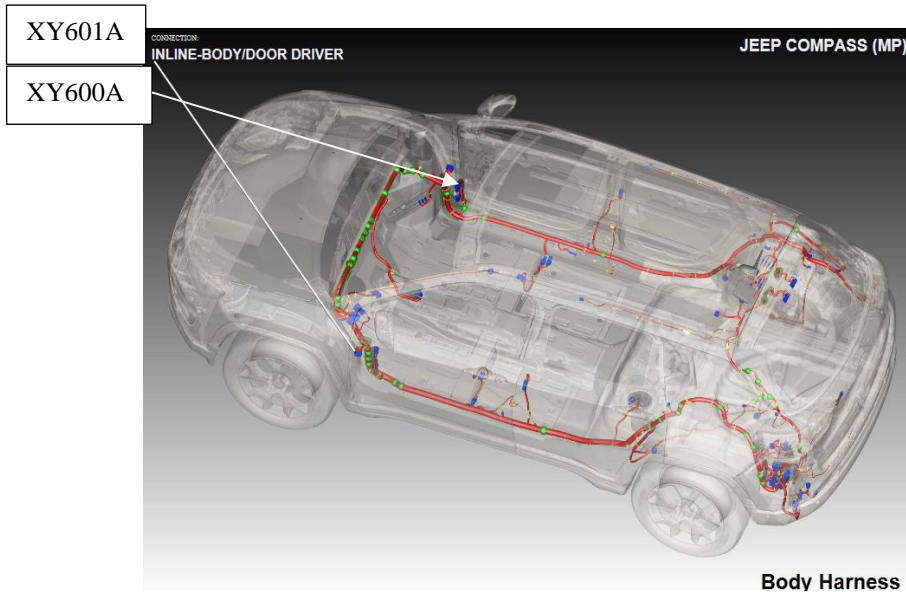
Driver or Passenger side may require inspection.
