STAR ONLINE PUBLICATION

Case Number: S2008000131 - Rev. B

Symptom/Vehicle Issue: U11E9 Lost Communication With AGS (Active Grille Shutter), Malfunction Indicator Lamp (MIL) Illuminated

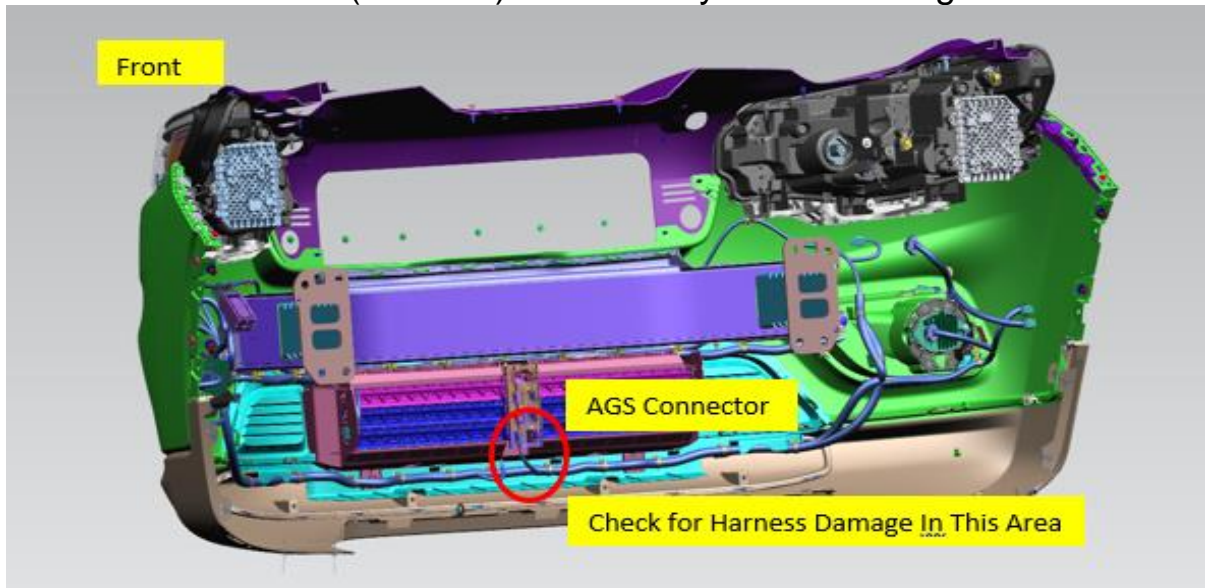
Diagnosis: Scan the vehicle for DTC's. If DTC U11E9 – Lost Communication with AGS is active or stored a wiring concern likely exist. Before replacing the AGS, inspect the wiring harness for signs of damage. Small cuts or nicks in the wiring harness have been found by engineering. Including circuits A940B, D511A, Z985BB. You should also confirm the AGS Connector(D2826A) is seated by disconnecting and reconnecting it.

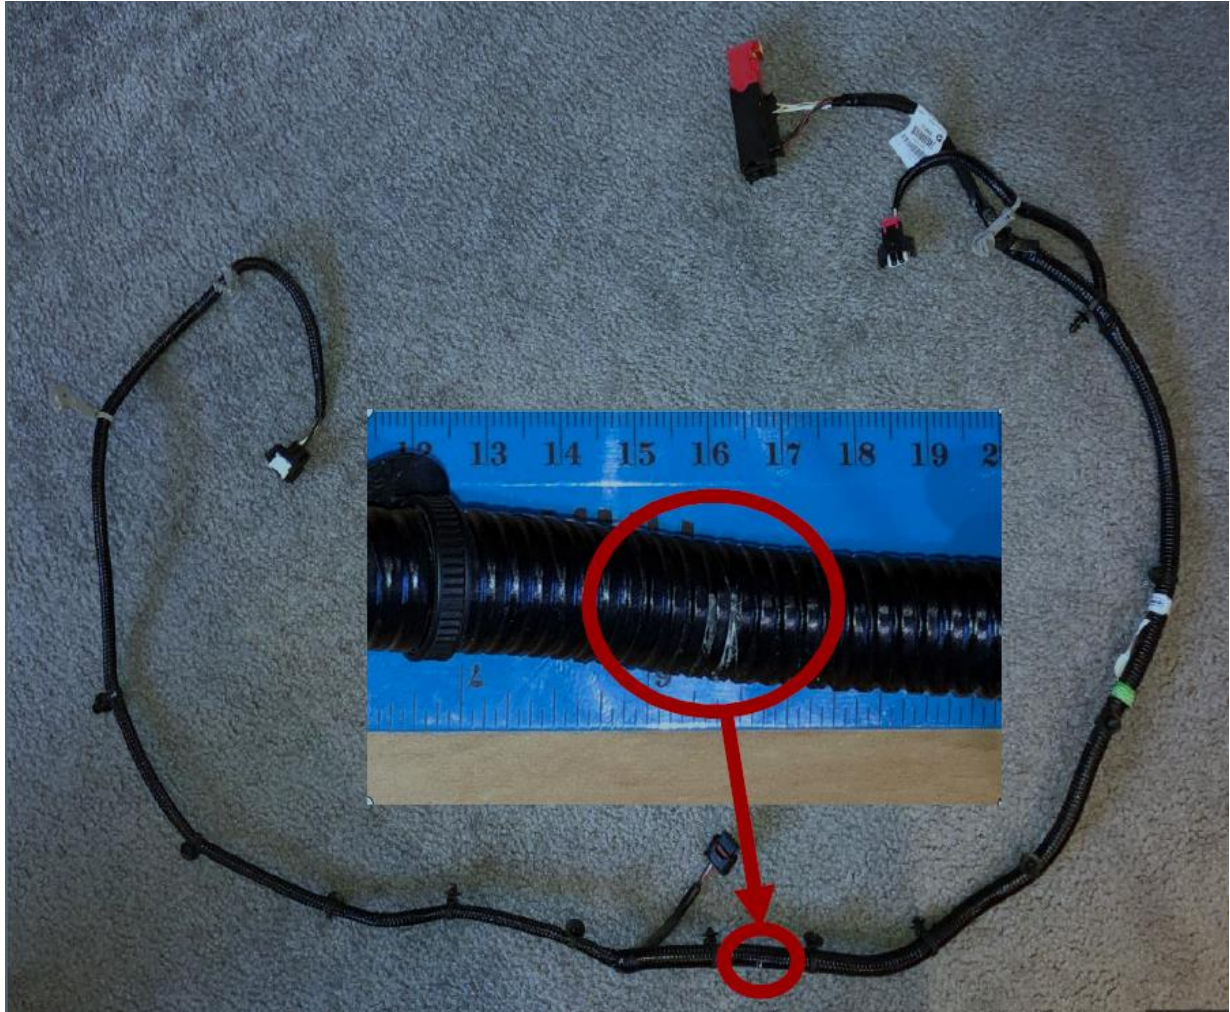
Discussion: Damaged fascia wiring harnesses are causing a loss of communication with fully functioning Active Grill Shutter(AGS) units.

Damaged AGS Wiring Harness

Repair: Use wiring kit 68396618AB to repair the fascia wiring harness or replace the harness if standard repair methods cannot be applied.

It is also advised to inspect the AGS connector for corrosion. If corrosion is present inside the AGS connector, the AGS connector and AGS will need to be replaced.
