## STAR ONLINE PUBLICATION

**Case Number:** S2008000167

**Symptom/Vehicle Issue:** Express Window Auto Up Feature Does Not Operate

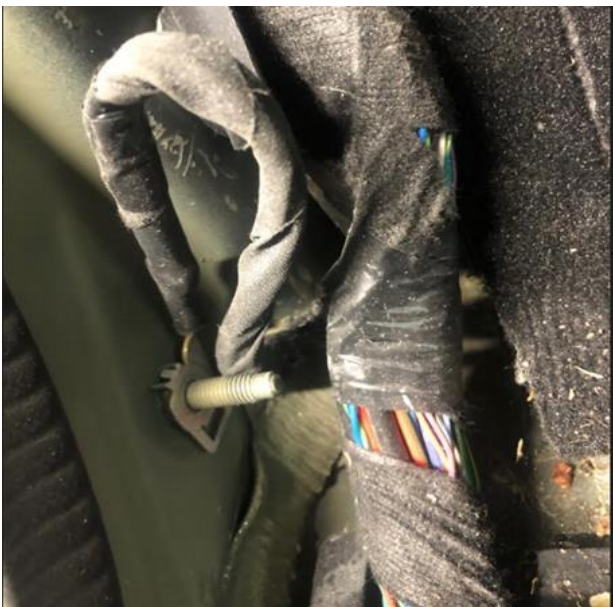
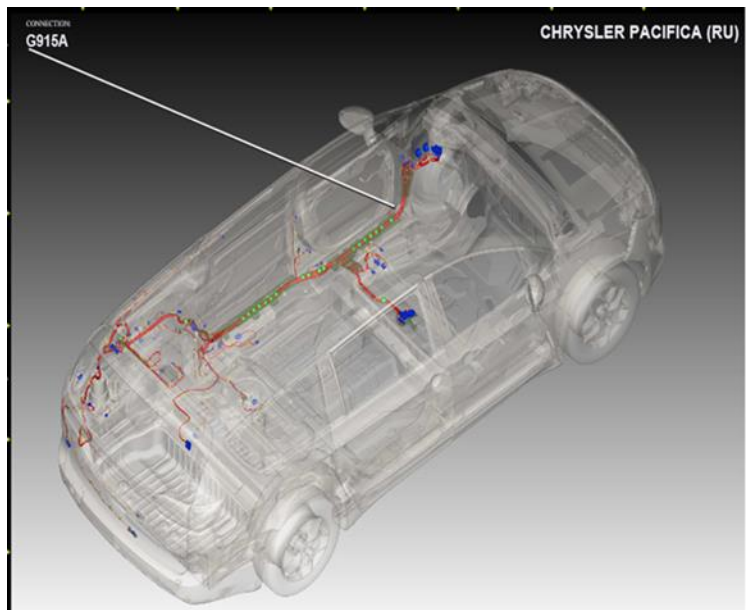
**Customer Complaint/Technician Observation:** Owner complains that the window auto up feature does not operate. Technician observed DTC B224F-54 - Door Module Internal-Missing Calibration. The module cannot be calibrated; after calibration the module loses what was learned.

Example below on a 2017 RU DDM (Driver Door Module) ground location G915A.

**Discussion:** Memory settings and calibrations are connected to the modules B+ feed and or ground circuits. Voltage drop the modules power and ground sources prior to any calibrations updates and correct as needed. No parts required.
