This bulletin supersedes Technical Service Bulletin 23-001-20 REV. C, dated August 11th, 2020, which should be removed from your files. All revisions are highlighted with **asterisks**** and include an updated parts table.**

Leather Instrument Panel (IP) Cover Delaminating - X81 Warranty Extension

2011 - 2014 (WK) Jeep Grand Cherokee

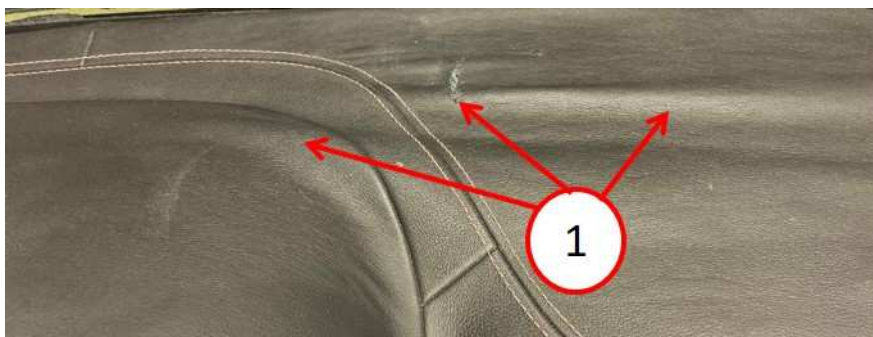
- The upper leather IP cover is delaminating or separating.

Fig. 1
IP Upper Cover Delamination

This bulletin involves replacing upper leather IP covers that have suffered delamination issues.

1. Were digital photos taken of the VIN, IP cover at both A-pillars, IP cover damage and the entire width of IP cover submitted and approval given?
 - YES>>> Proceed to [Step 2](#) of the Repair Procedure.
 - NO>>> Take photos of the VIN, IP cover at both A-pillars, IP cover damage and the entire width of IP cover and submit for approval.
2. Replace the upper IP cover. Refer to the detailed procedures available in DealerCONNECT > Service Library> under: 23 - Body/Instrument Panel/Cover, Instrument Panel/Removal/Installation.

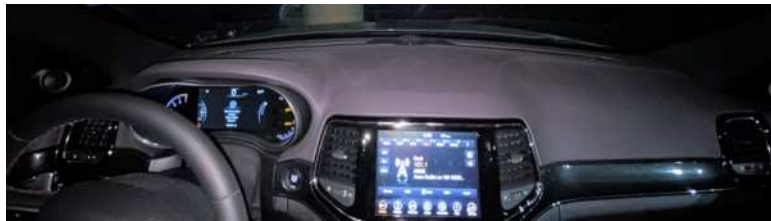
Fig. 2
Entire Width Of IP Cover For Claim Submittal
