NUMBER: 09-012-20

Engine Ticking Noise

This bulletin involves replacing the bank 1 exhaust cam phaser, phaser actuator and Oil Control Valve (OCV).

2020 (RU) Chrysler Pacifica

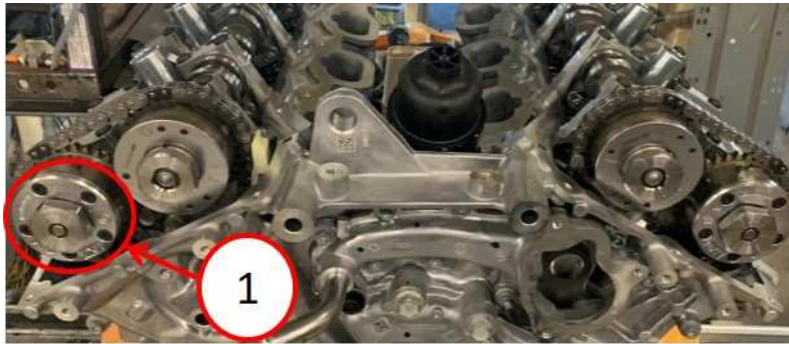
Fig. 1

Bank 1 Exhaust Cam Phaser Actuator And OCV

1- Bank 1 Exhaust Cam Phaser And Oil Control Valve

1. Replace the **bank 1 exhaust cam phaser**, phaser actuator and OCV (**Fig. 1**) . Refer to the detailed service procedures available in DealerCONNECT/Service Library under: Service Info>09 - Engine, 3.6L / Cylinder Head / Assembly, Variable Valve Timing, Phaser / Oil Control Valve / Removal and Installation.
