Service Bulletin

Bulletin No.: 16-NA-380

Subject: Diagnostic Tip for Malfunction Indicator Lamp (MIL) Illuminated, Excessive Smoke from Tail Pipe - DTC P2002, P226D and/or P244A Set

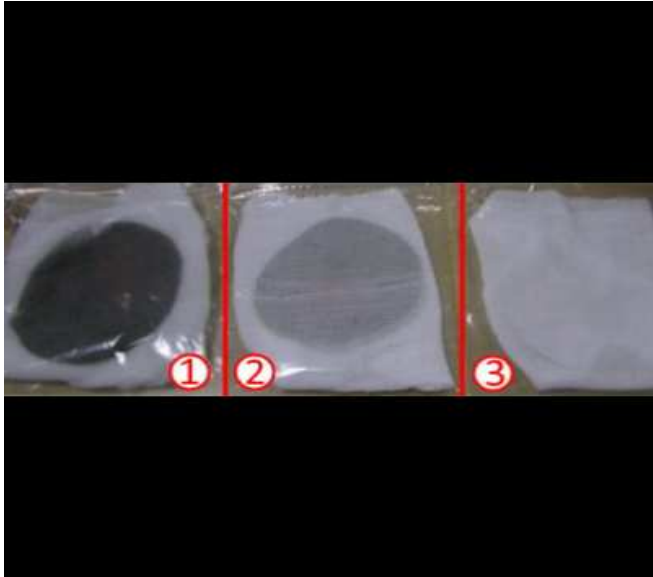
5615225

- A failed test will show excessive soot particulates on the cheese cloth or equivalent (1, 2). Refer to the graphic above. These soot particles indicate that the exhaust particulate filter is no longer able to capture all of the soot particles in the exhaust stream and it needs to be replaced.
- A passing test will show no, or very minimal, signs of soot particulates (3). These soot particulates indicate that the exhaust particulate filter is able to capture the soot particles in the exhaust stream and it does not need to be replaced.

If the vehicle sets DTC P2002, P226D or P244A and SI diagnostics lead to DPF replacement, use the cheese cloth test to confirm if the DPF needs to be replaced.
