# Service Bulletin

Bulletin No.: 17-NA-299

**Subject:** Information on Michelin Selfseal® Tires Inspection and Repair Procedures

| Brand: | Model: | Model Year: | | VIN: | | Engine: | Transmission: |
|---|---|---|---|---|---|---|---|
| Chevrolet | Bolt EV | 2017 | 2020 | — | — | — | — |

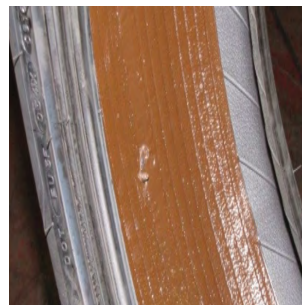
4864854

1. Identification of puncture inside tire.
