Service Bulletin

Bulletin No.: 19-NA-110

Subject: Visible Cracks in Shock Tower Near Strut Top Mount

Brand:	Model:	Model Year:		VIN:		Engine:	Transmission:
		from	to	from	to		
Chevrolet	Camaro	2016	2021	—		All	All

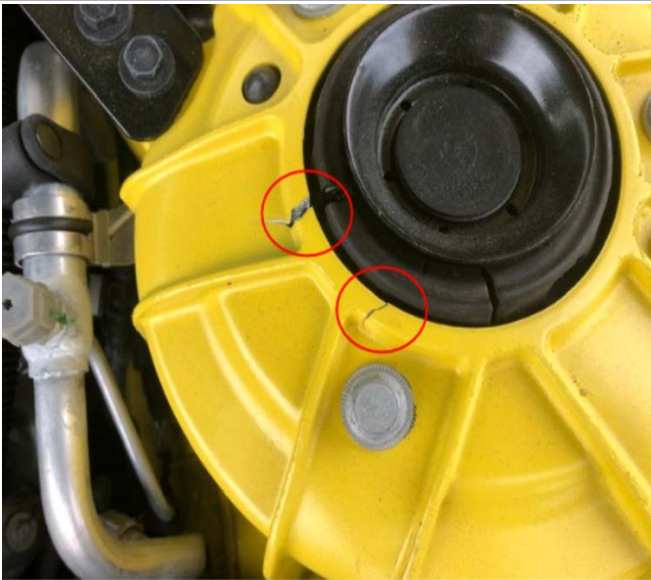
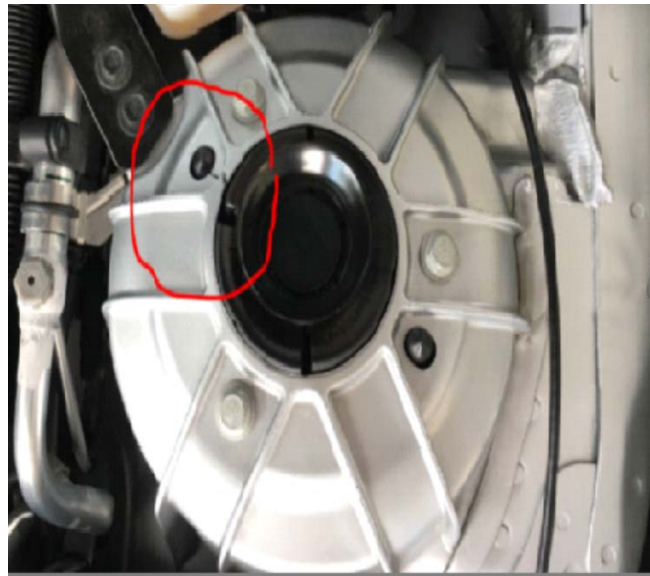
Some customers may comment on seeing cracks on the shock tower, near the strut top mount. Some examples are shown in the graphics above.

Cause	The cause of the condition may be a hard impact (such as curb or pot hole) that drives a lot of energy up through the strut tower casting, ultimately cracking it.
Correction	To repair this condition, the shock tower must be replaced. Refer to <i>Front Wheelhouse Panel Replacement (Partial)</i> or <i>Front Wheelhouse Panel Replacement (Complete)</i> in SI. Note: Vehicles repaired for the conditions outlined in this bulletin should not be considered warranty. Any warranty claims submitted with these conditions may be debited.
