Service Bulletin

Bulletin No.: 18-NA-114

Subject: Service All Wheel Drive (AWD)/Service Stability Messages and/or Low Oil Pressure Shut Off Engine Message Displayed in Driver Information Center (DIC), Erratic Speedometer Readings, Malfunction Indicator Lamp (MIL) Illuminated - DTC P0641, U0073, U0100, U0101, U0121, U0131, U0136 and/or U1814 Set

Brand:	Model:	Model Year:		VIN:		Engine:	Transmission:
		from	to	from	to		
Chevrolet	Trax	2018	2020	—	—	1.4L (LUV)	—

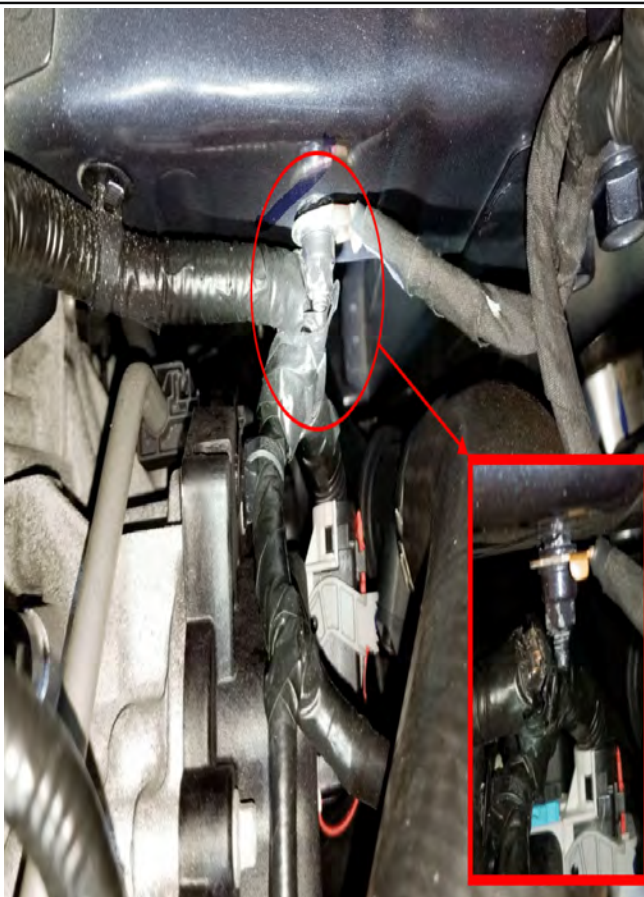
5040432

Cause	<p>Note: This is a multi-wire bundled harness and, depending on which wire is damaged, can set a variety of DTCs.</p> <p>This condition may be caused by the engine harness chaffing against the G100 Ground stud.</p>

If the above condition has been validated, inspection of the engine wiring harness must be done.

1. With a suitable light, inspect the wiring harness point of contact at the G100 ground stud.
- ⇒ For stud location, refer to Document ID: 4708510 in SI.
2. Repair the harness as needed.
- ⇒ Refer to *Wire to Wire Repair* in SI.
