# Service Bulletin

Bulletin No.: 18-NA-276

**Subject: Paint Wear Mark or Chip at Corner of Rocker Panel Molding from Door Over-Slam Hem Seal Contact**

Brand:	Model:	Model Year:		VIN:		Engine:	Transmission:
		from	to	from	to		
Chevrolet	Camaro	2016	2021	—	—	All	All

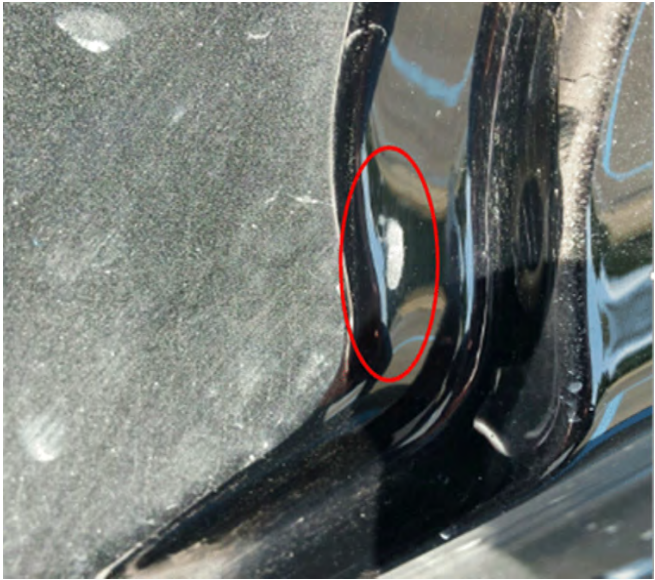
5141520

<p style="text-align: right;">5141522</p> <p>Some customers may comment on a paint chip or wear mark (marring) on one, or both, of the rocker panel moldings. Several examples of the condition are shown in the graphics above.</p>
<p><b>Cause</b></p>	<p><b>Note:</b> Adjusting the door WILL NOT resolve this issue.</p> <p>The cause of the condition may be because of a tight door hem sealer to rocker clearance, by design. The marring or chipping happens when the door makes contact with the rocker during door closure (over-slam). This is NOT a rub condition once the door is closed.</p>
<p><b>Correction</b></p>	<p><b>Important:</b> DO NOT adjust the door and DO NOT replace the rocker panel molding for this condition.</p> <p><b>Note:</b> Refer to the latest revision of the GM Approved Refinish Materials book to identify the paint systems you may use that have been engineered to meet GM standards.</p> <p>The latest revision of the GM Approved Refinish Materials booklet is located on the Genuine GM Parts website at <a href="http://www.genuinegmparts.com">www.genuinegmparts.com</a> and also within the "Unit Repair Manual/Specialty Publication" section of GM Service Information (SI).</p> <p>Complete a partial paint repair to the rocker(s) to correct the condition.</p>
