# Service Bulletin

Bulletin No.: 19-NA-030

**Subject:** Information on High Power Steering Temperature During Track Use, Loss of Power Steering Assist, and/or Steering Effort Reduced Message in Driver Information Center (DIC)

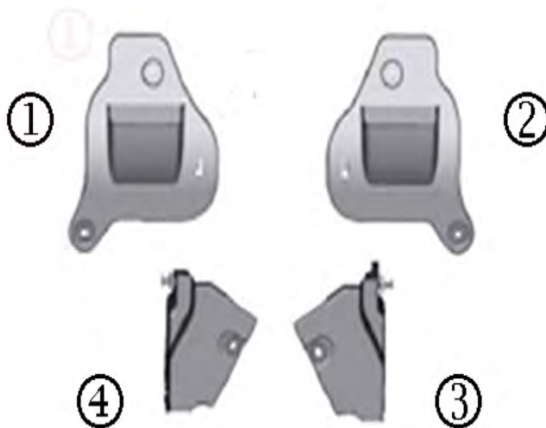
5226118

<b>Involved Region or Country</b>	North America, Europe, Russia, Middle East, Israel, Argentina, Brazil, Bolivia, Chile, Colombia, Ecuador, Paraguay, Peru, Uruguay, Japan, GM Korea Company, China, Taiwan, Philippines
<b>Condition</b>	Some customers may comment on a loss of power steering assist and a Steering Effort Reduced message displayed on the DIC. This occurs during track events in extreme heat.
<b>Cause</b>	This may be caused by reduced air flow around the power steering gear during extreme track temperatures.
<b>Correction</b>	<p><b>Install Power Steering Deflectors for track use only. Follow the installation instructions included with the deflector kit.</b></p> <p>The contents of the deflector kit are shown in the graphic below: Right (1) and left (2) Deflectors, and left (3) and right (4) Shield Supports.</p>

- Keep the two side shields and side shield screws so the side shields can be reinstalled after track use. The remaining fasteners will be used to attach the deflectors and shield retainers.
- Before driving on public roads, the deflectors should be removed and the original shields should be reinstalled.
- Installation time is approximately 10 minutes with the vehicle on a hoist.

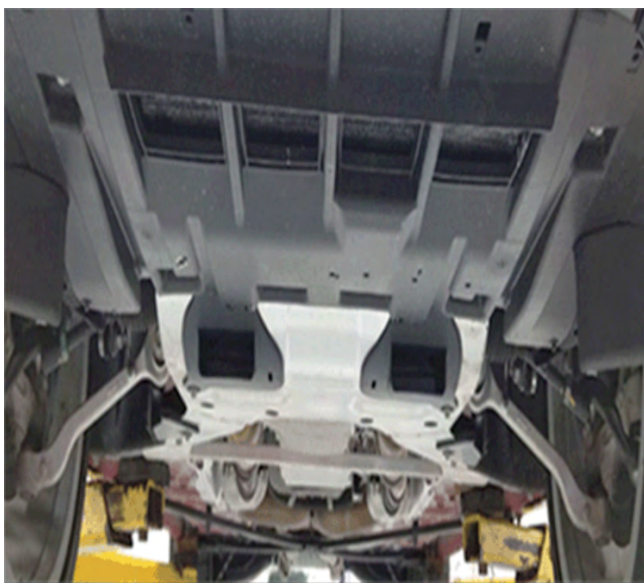
5249064

**Graphic with Power Steering Deflectors Installed**
