Service Bulletin

Bulletin No.: 19-NA-116

Subject: Pulse, Grinding, Scraping Noise from Brakes, Uneven Front Brake Pad Wear

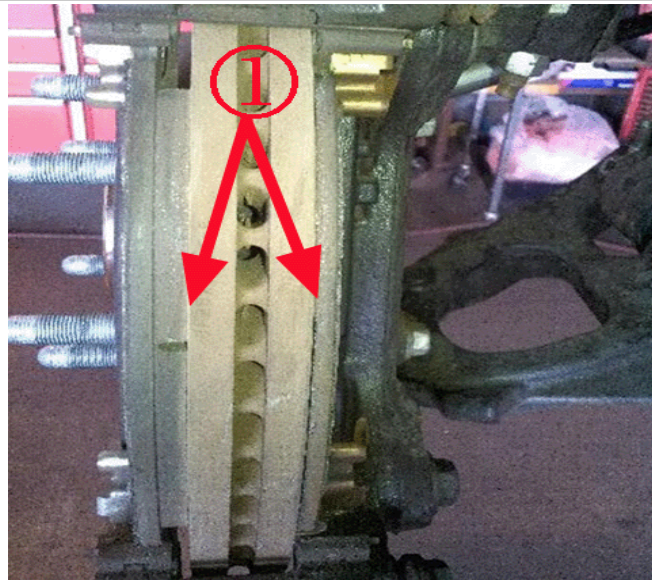
4008926

Shown above is an example from one vehicle with uneven wear. Photo 1 is of the left front brake pads where the inner pad is worn completely out, while the outer pad still has plenty of pad life. Photo 2 is from the same vehicle, but of the right front inner and outer brake pads, which both have plenty of pad material left.

1. Inspect and measure the brake pads thickness. Determine the type of driving the owner does and compare the measurements to the information listed above (3mm or 6mm).

- If the pads are **within specification**, disregard this bulletin and perform a normal brake repair.
 - If the pads are **out of specification**, perform normal SI diagnostics to determine the cause of the concern (caliper piston binding, binding pads or guide pins in bracket, brake hose restriction, etc).

2. After completing normal diagnostics, if a root cause for the uneven pad wear is not found, replace the front brake pads with the part number in the table below. Refer to the *Brake Rotor Surface and Wear Inspection*, in SI to determine if the brake rotor(s) require servicing or replacement. If the brake rotors require service due to excessive heat checking/blueing, it is recommended to replace the rotors rather than attempting to refinish the rotor(s) for this issue. Refer to the parts catalog for the correct O.E.M. rotor part number, which are Ferritic Nitro-Carburizing (FNC) rotors.
