Service Bulletin

Bulletin No.: 19-NA-206

Subject: Intermittent Shift to Park Message Displayed While Vehicle in Park

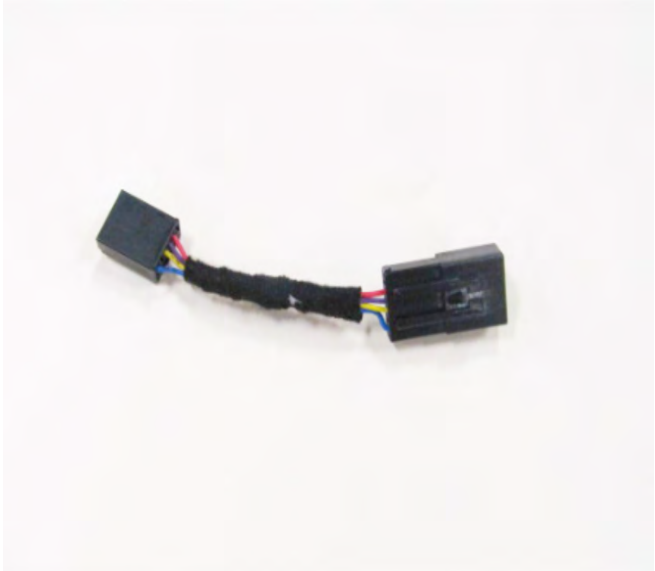
Involved Region or Country	North America, Europe, Russia, Middle East, Israel, South America, Japan, South Korea, China, Thailand, Australia, New Zealand, Africa
Condition	Some customers may comment on seeing an intermittent Shift to Park message when the vehicle has been shifted into Park, and the ignition has been turned to the Off position. Aside from seeing the message, technicians may find DTC B000A set.
Cause	The cause of the condition may be that the park switch in the transmission control (shifter) assembly is not pulling the BCM signal low to electronically show that the vehicle is in the Park position.
Correction	<div style="text-align: center;">

</div> <p style="text-align: right; font-size: small;">5386336</p> <p>Verify the condition and following the steps in the Service Procedure below, install an In-line Shifter Wire Harness Jumper between the shifter base connector and the console harness connector.</p>

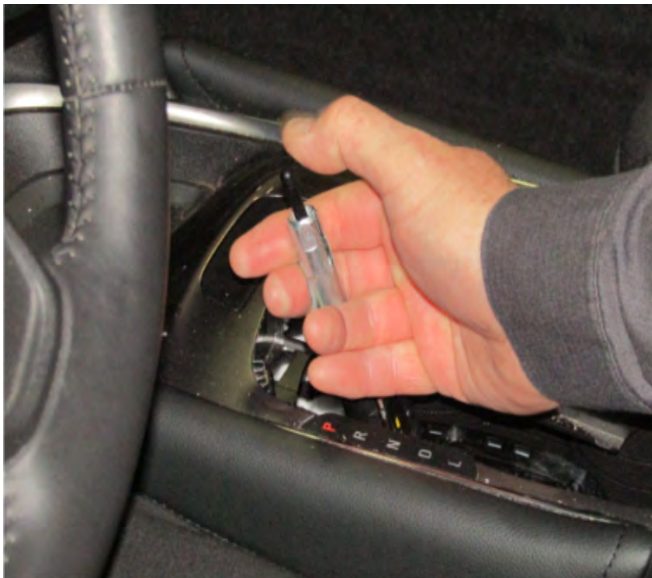
5386341

Important: Cleaning the Park Switch electrical contacts is a very critical part of the repair procedure. Ensure these steps are not overlooked.

3. Clean the Park Switch electrical contacts by completing the following steps:

- 3.1. Depress the actuation rod fully with your thumb or a trim stick.
- 3.2. Release the actuation rod by sliding your thumb or the trim stick off the rod, allowing the rod to "snap" back to the full up position.
- 3.3. Repeat 50 times.
4. Start the vehicle and verify that the Shift to Park message is NOT displayed:
 - If the Shift to Park message IS STILL displayed, and/or the technician finds DTC B000A set, replace the shift control assembly AND proceed on to step #5. Refer to the appropriate *Transmission Control Replacement* in SI.
 - If the Shift to Park message IS NOT displayed, proceed ahead to step #5.
