Service Bulletin

Bulletin No.: 19-NA-235

Subject: Rattle or Ticking Noise from B-Pillar Area.

Brand:	Model:	Model Year:		VIN:		Engine:	Transmission:
		from	to	from	to		
Chevrolet	Equinox	2019	2020			All	All
GMC	Terrain

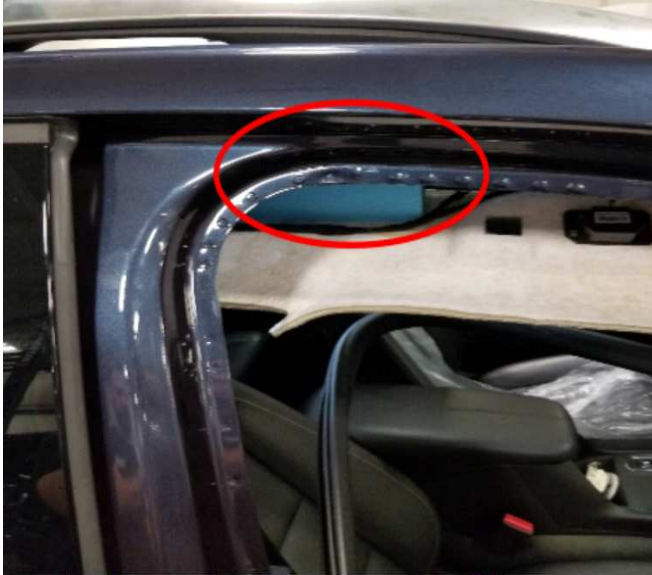
5422100

3. Locate the sheet metal area at the rear radius, shown in the graphic above.

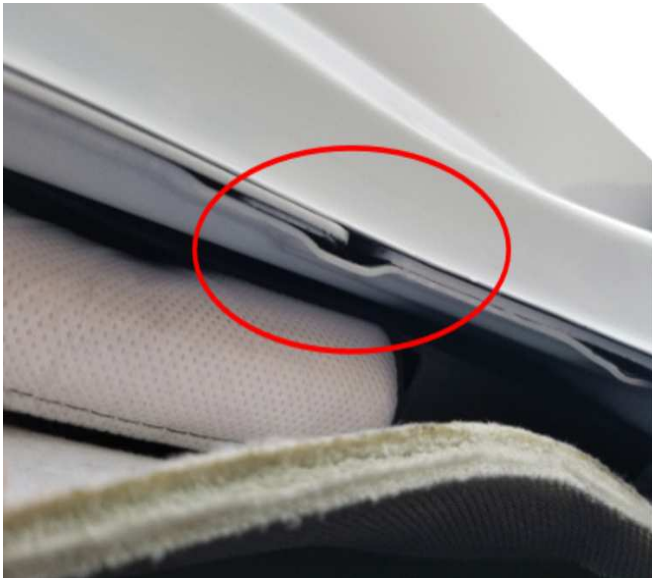
5422104

4. Locate the crease/gap in the sheet metal.
