# Service Bulletin

Bulletin No.: 20-NA-017

**Subject: Outward Bump on Surface of Front Fascia (ZL1 or ZL1 1LE for U.S. and Canada Dealers Only)**

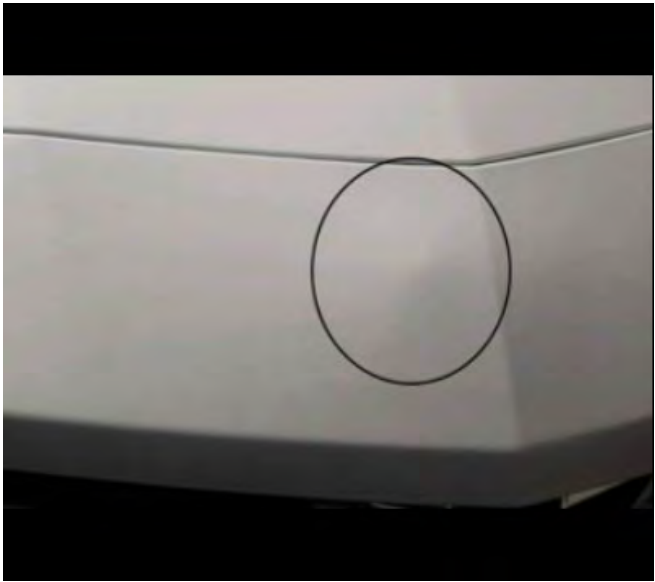
<p style="text-align: right; font-size: small;">5484962</p> <p>Some customers may comment on an outward bump appearance in the front fascia. This condition only occurs approximately 76 mm (3 in) on either side of the centerline of the fascia.</p>
<b>Cause</b>	This condition is caused by the corners of the grille support bracket creating an outward ding due to excessive downward force on the front fascia area.
<b>Correction</b>	<p><b>Important:</b> Before you repair a vehicle with this condition, please submit a Field Product Report along with pictures of the issue. In Canada, please submit a Product Information Report.</p> <p>Rework the fascia to remove the bump following the steps in the Service Procedure below.</p>
