# Service Bulletin

Bulletin No.: 20-NA-097

**Subject: Unwanted Radio Volume Ramp Up to Max, Radio Resets, Radio Display Blank, or Non-Responsive to Touch**

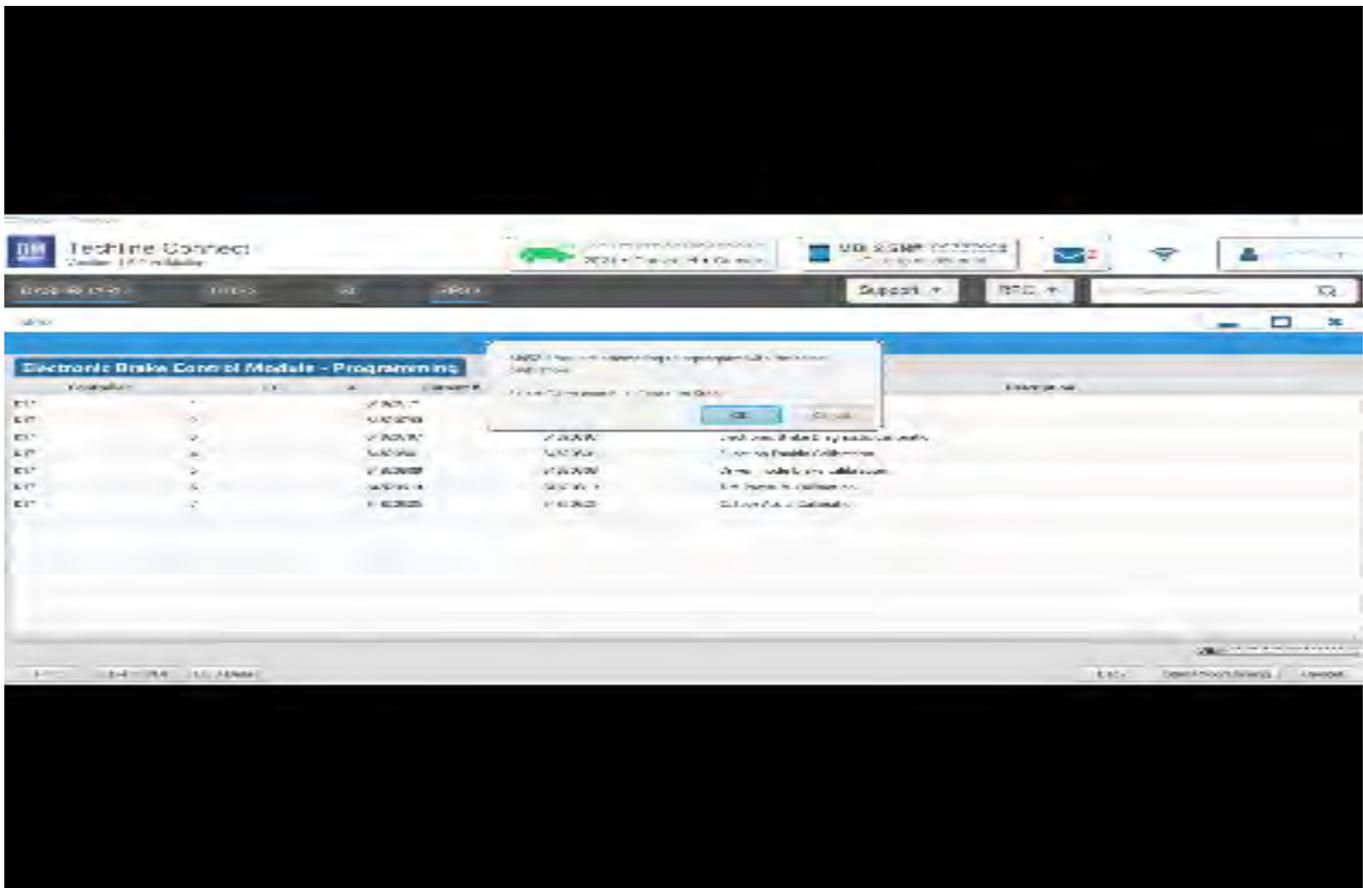
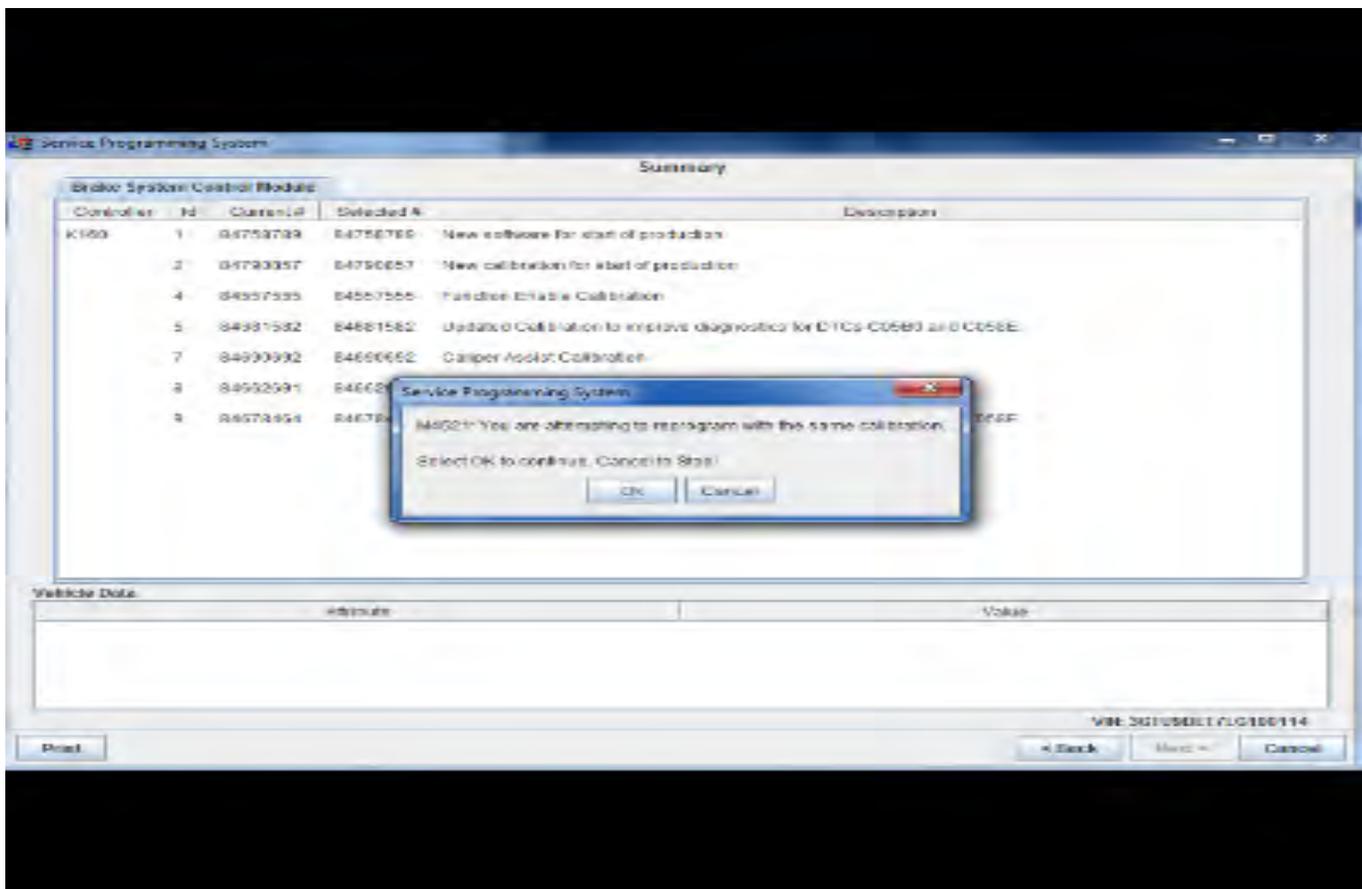
5431207

**Important:** Techline Connect and TIS2WEB screens shown above.

**Important:** : If the Same Calibration/Software Warning is noted on the TLC or SPS Summary screen, select OK and follow on-screen instructions. The system will generate a warranty claim code (WCC) for documentation purposes only. Perform service information (SI) diagnostics to determine the cause of the condition. Use the applicable labor operation code when submitting a warranty claim. Do NOT use the WCC with the warranty claim submission.
