Service Bulletin

Bulletin No.: 20-NA-179

Subject: Malfunction Indicator Lamp (MIL) Illuminated – DTCs P0521 and/or P06DD Set

Brand:	Model:	Model Year:		VIN Breakpoint:		Engine:	Transmission:
		from	to	from	to		
Chevrolet	Corvette	2020	2020	SORP	September 10, 2020	6.2L (LT2)	—

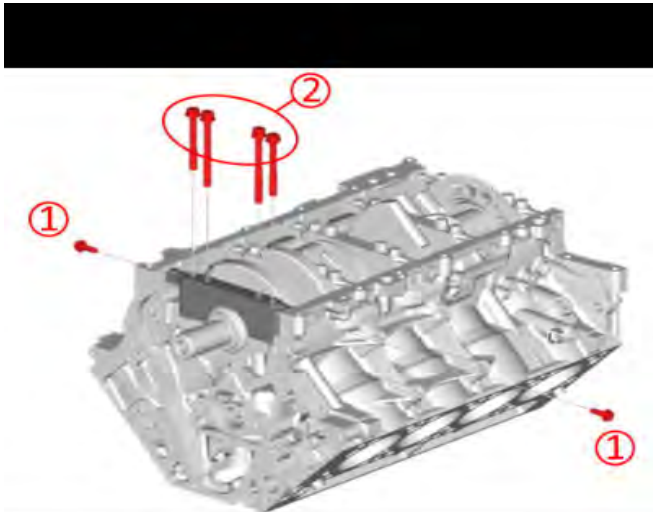
5633412

Note: The generator may need to be repositioned to gain access to the main cap side bolts.

2. Remove the main cap side bolts (1).

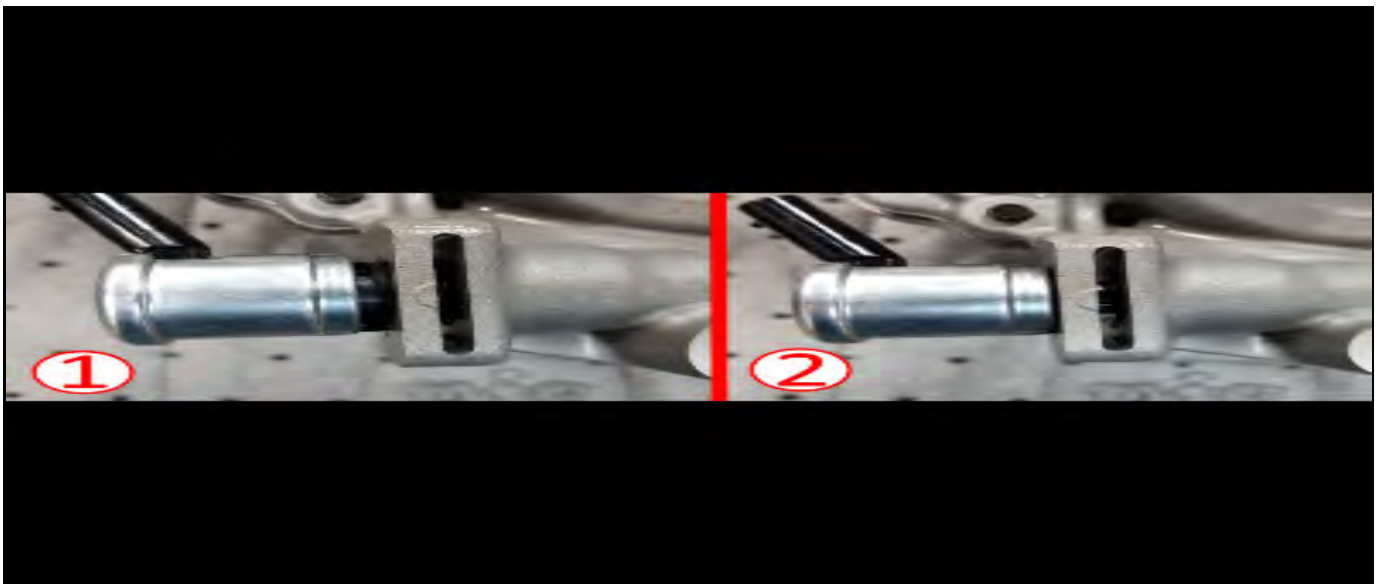
5633444

4. Inspect the OCV:
 - If you find this oil pressure control valve dislodged (1), it will be necessary to install a redesigned oil control valve retainer.
5. Disconnect the oil pressure control valve electrical connector and position aside.
