# Service Bulletin

Bulletin No.: 20-NA-202

**Subject: Liftgate Hands-Free Inoperative or Unwanted Opening**

Brand:	Model:	Model Year:		Date Breakpoint:		Engine:	Transmission:
		from	to	from	to		
Cadillac	XT6	2021	2021	SOP	Built Prior to September 17, 2020

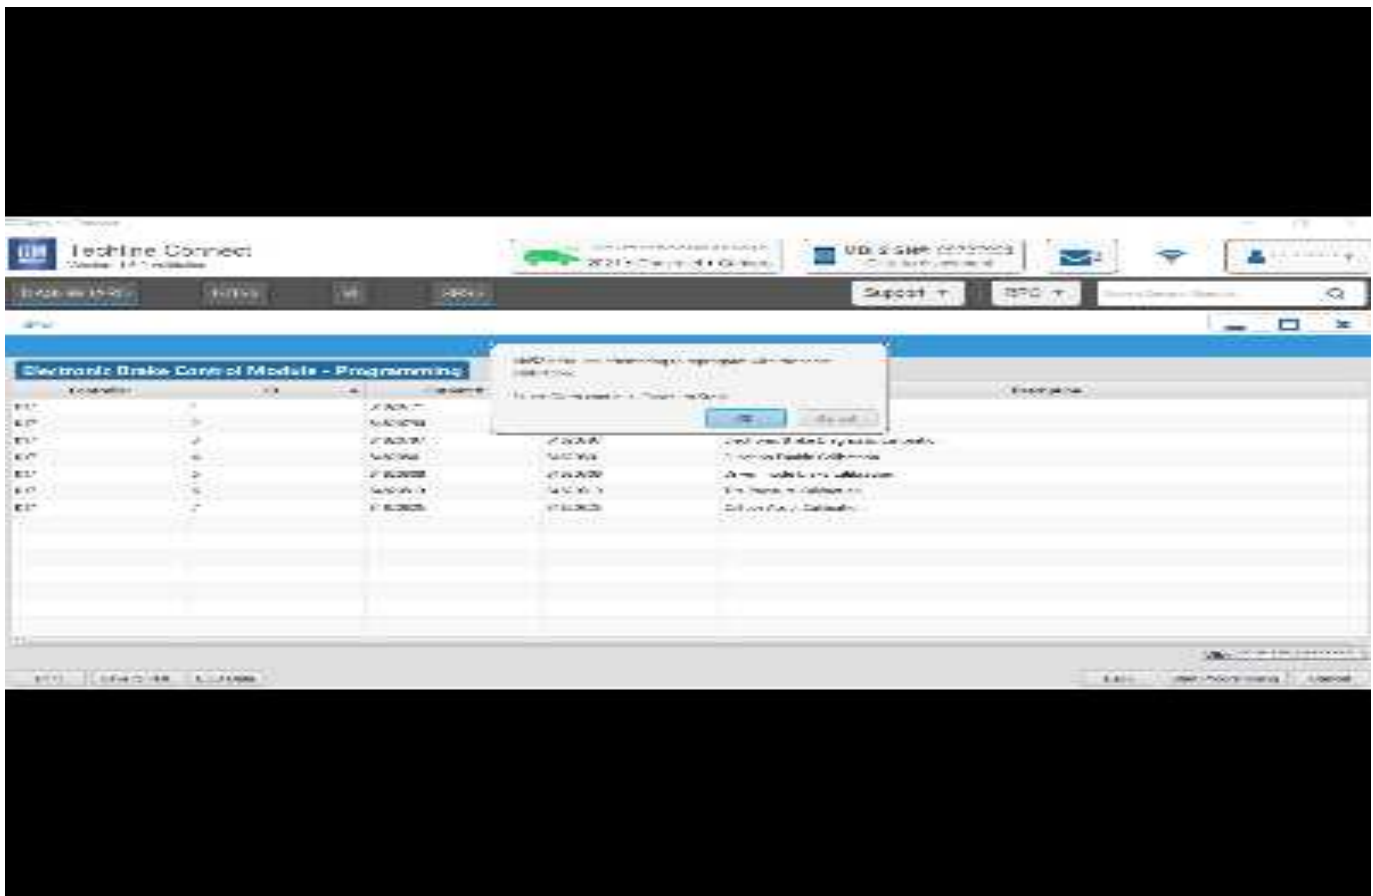
5644477

**Important:** Techline Connect and TIS2WEB screens shown above.
