Service Bulletin

Bulletin No.: 20-NA-204

Subject: Cylinder Deactivation Performance, Malfunction Indicator Lamp (MIL) Illuminated - DTC(s) P3498, P3499, P349A, P349B, P349C, P349D, P349E, and/or P349F May Be Active or Stored in History

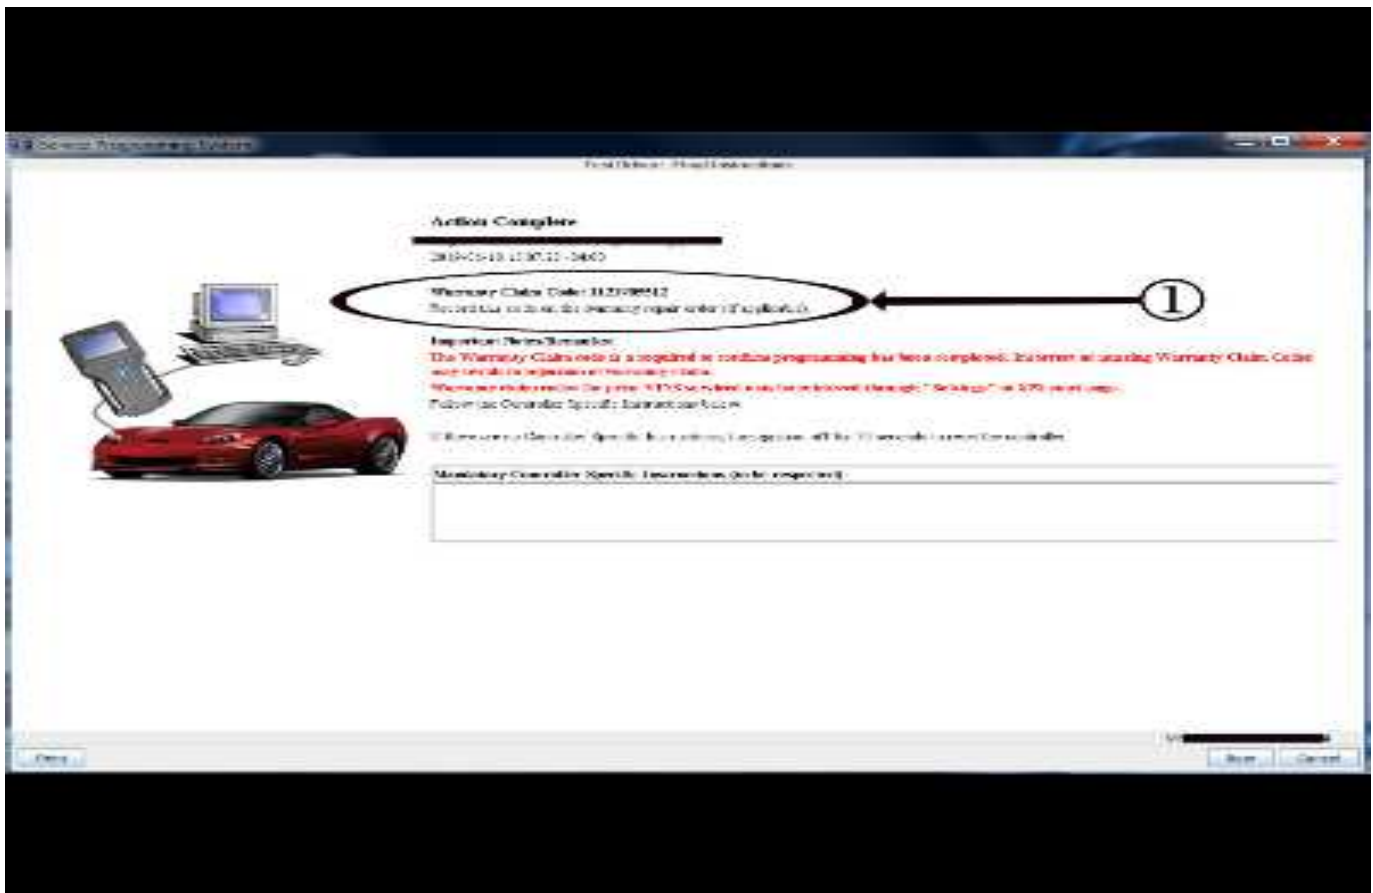
5431209

Important: To avoid warranty transaction rejections, you **MUST** record the warranty claim code provided on the SPS Warranty Claim Code (WCC) screen shown above on the job card. Refer to callout 1 above for the location of the WCC on the SPS screen

- Record SPS Warranty Claim Code on job card for warranty transaction submission.
