Service Bulletin

Bulletin No.: 20-NA-210

Subject: All-Wheel Drive Off and/or Service All-Wheel Drive System Messages Displayed in the DIC

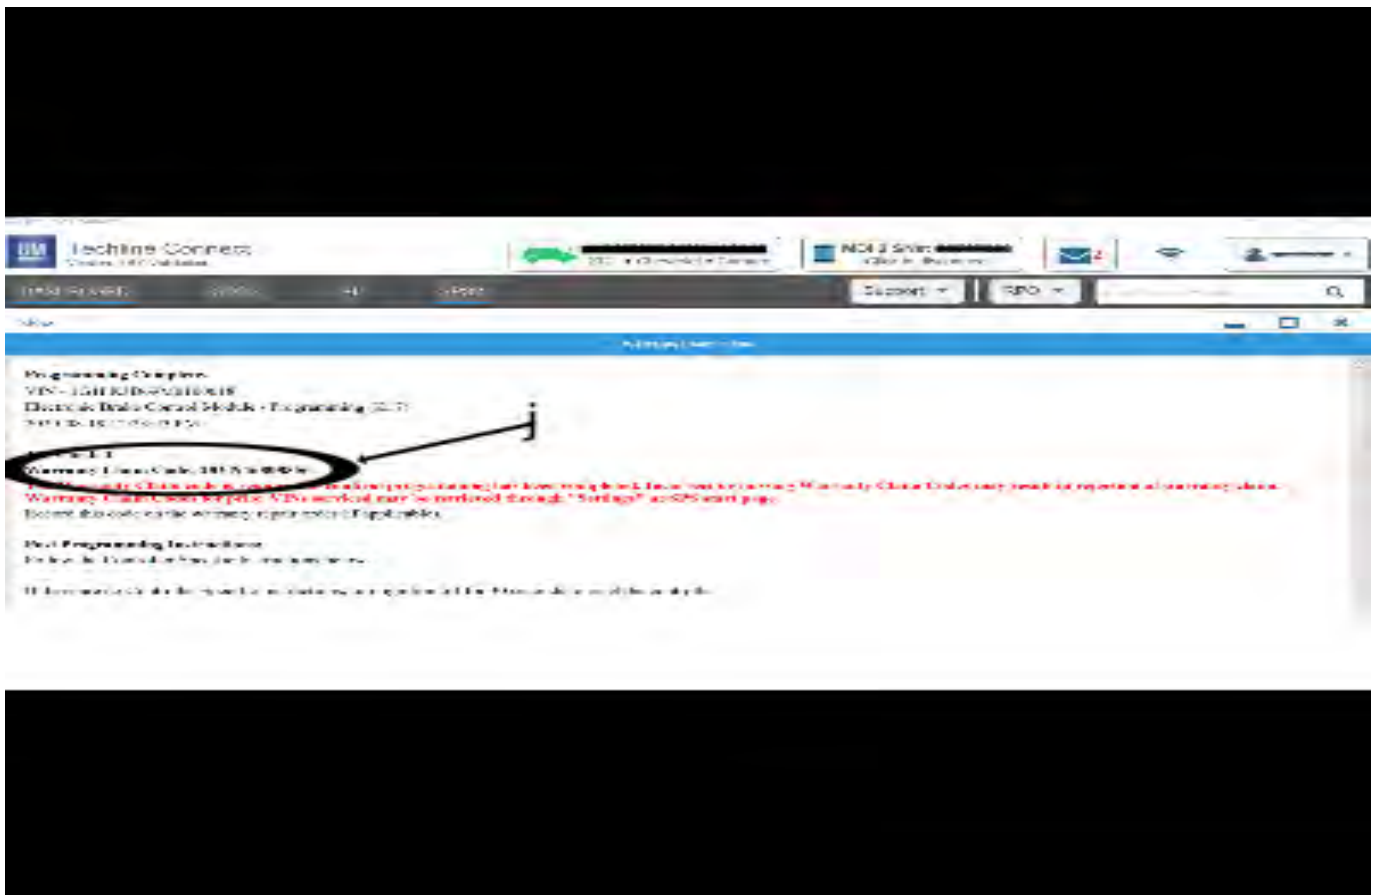
5431209

Important: To avoid warranty transaction rejections, you **MUST** record the warranty claim code provided on the SPS Warranty Claim Code (WCC) screen shown above on the job card. Refer to callout 1 above for the location of the WCC on the SPS screen

2. Record SPS Warranty Claim Code on job card for warranty transaction submission.
