# Service Update

## N202293610 Electronic Transmission Range Select Mode Valve Stuck

Release Date: October 2020

<b>Condition</b>	Certain 2019 model year Cadillac CT6 vehicles may have a condition which can cause the transmission auxiliary pump to stay on when DTC P18AA is set at engine off.
<b>Correction</b>	Dealers are to reprogram the transmission control module.

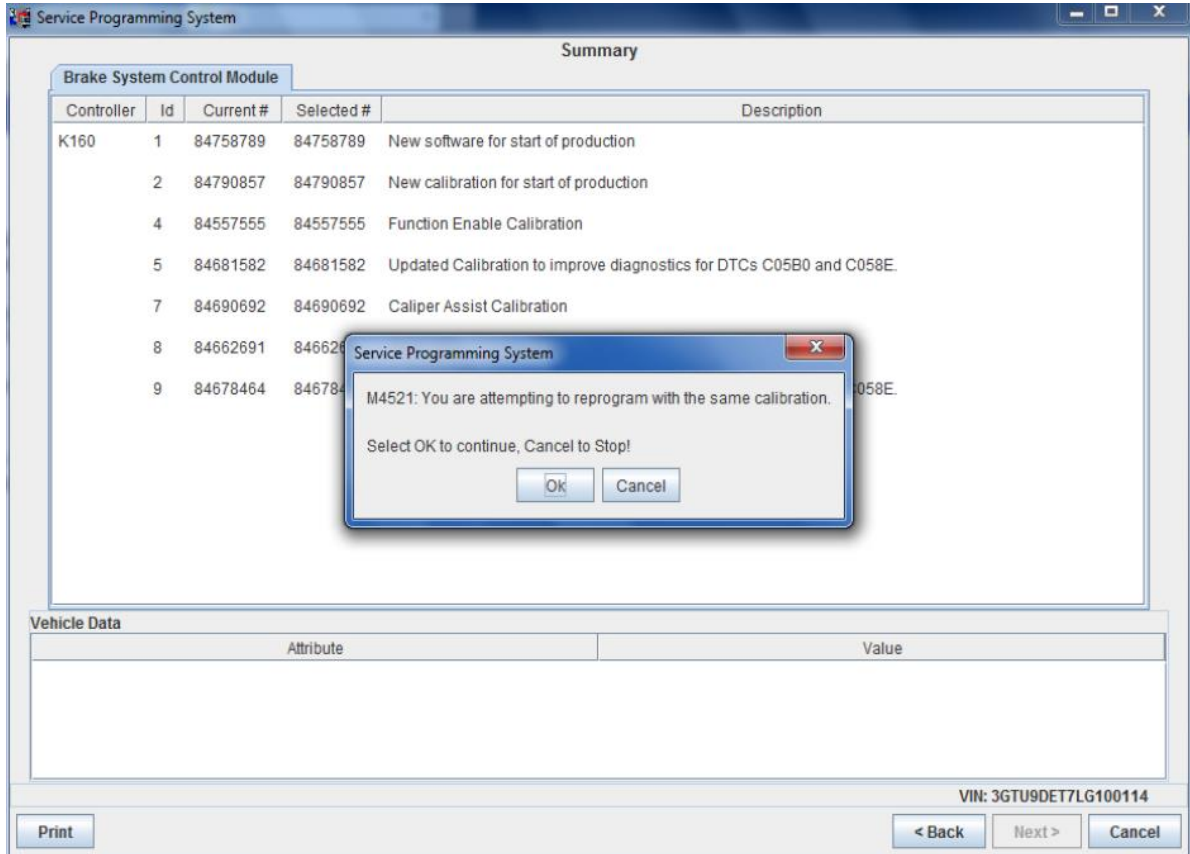
5431207

**Important:** If the Same Calibration/Software Warning is noted on the SPS screen, select OK and follow screen instructions. After a successful programming event, the WCC is located in the Service Programming System dialogue box of the SPS Summary screen. No further action is required. Refer to the Warranty section of the bulletin.

1. Reprogram the Transmission Control Module. Refer to *K71 Transmission Control Module: Programming and Setup* in SI.
  - Select "Refresh Characterization Data" when prompted to select a programming type.

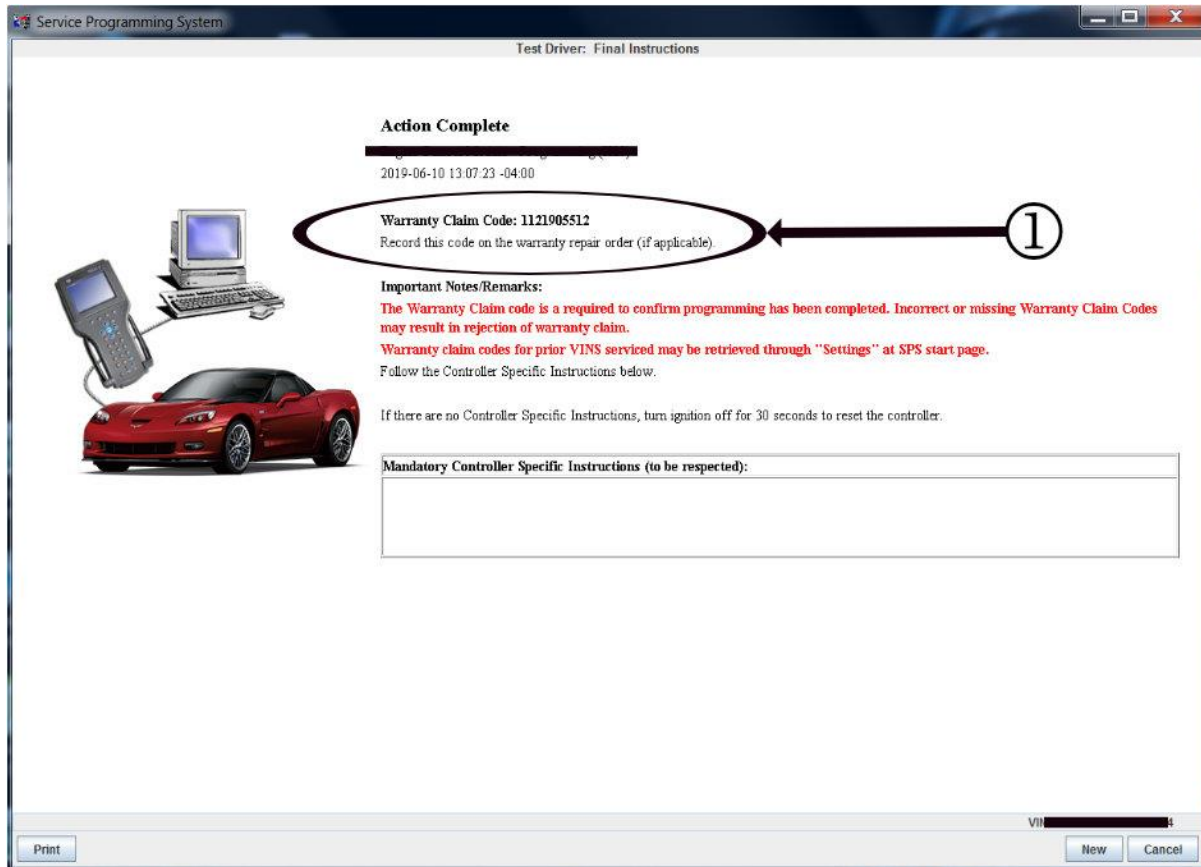
5431209

**Important:** To avoid warranty transaction rejections, you **MUST** record the warranty claim code provided on the SPS Warranty Claim Code (WCC) screen on the job card. Refer to callout 1 above for the location of the WCC on the SPS screen.

2. Record SPS Warranty Claim Code on job card for warranty transaction submission.
