Subject: N202317390 - Customer Satisfaction Program
Brake System Control Module Internal Fault

Models: 2021 Cadillac Escalade, Escalade ESV
2021 Chevrolet Suburban, Tahoe
2021 GMC Yukon, Yukon XL

Customer Satisfaction Program

N202317390 Brake System Control Module Internal Fault

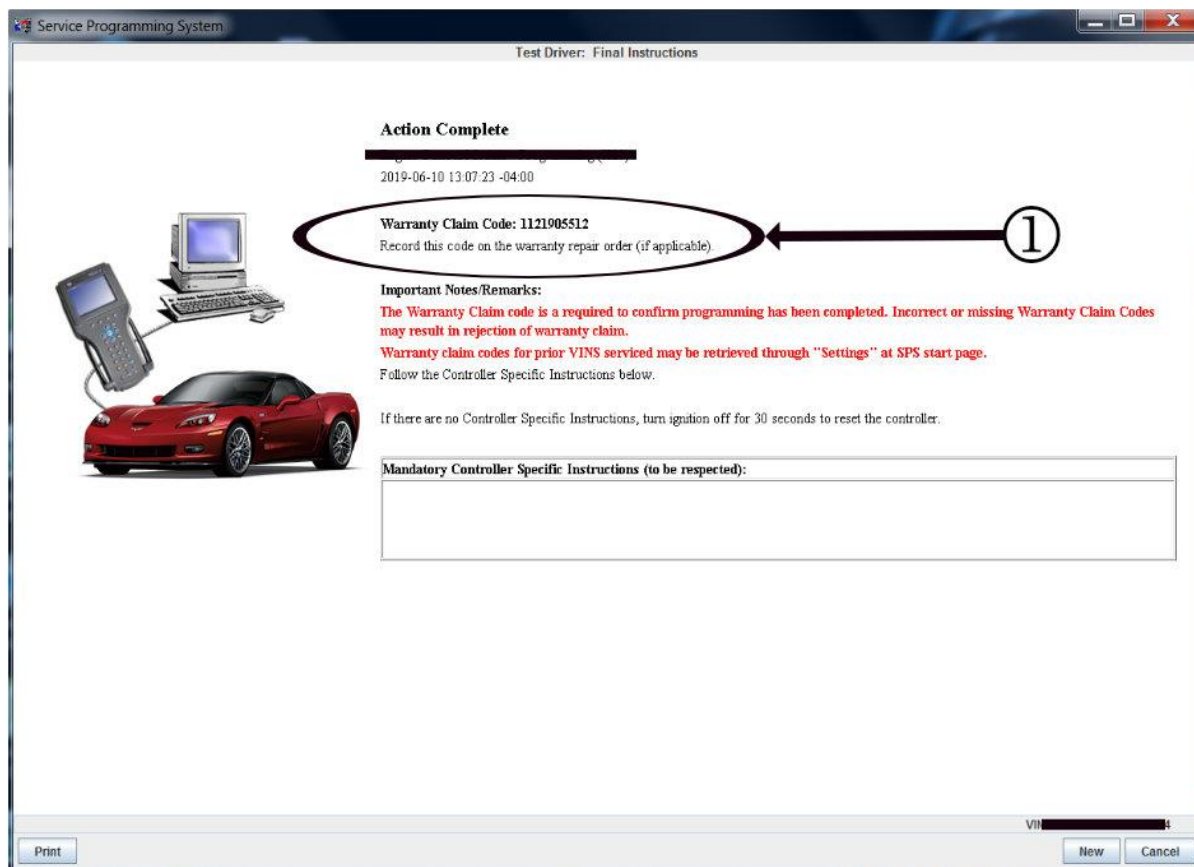
5431209

Important: To avoid warranty transaction rejections, you **MUST** record the warranty claim code provided on the Warranty Claim Code (WCC) screen shown above on the job card. Refer to callout 1 above for the location of the WCC on the screen.

- Record SPS Warranty Claim Code on job card for warranty transaction submission.
