## Noise Complaints At Front Axle Support Bushing

| Topic number | LI32.25-P-066247 |
| Function group | 32.25 Shock absorbers, damper struts, spring struts |
| Validity | Models 205, 253, 213<br>without SA 489 / AIRMATIC<br>without AMG BM |

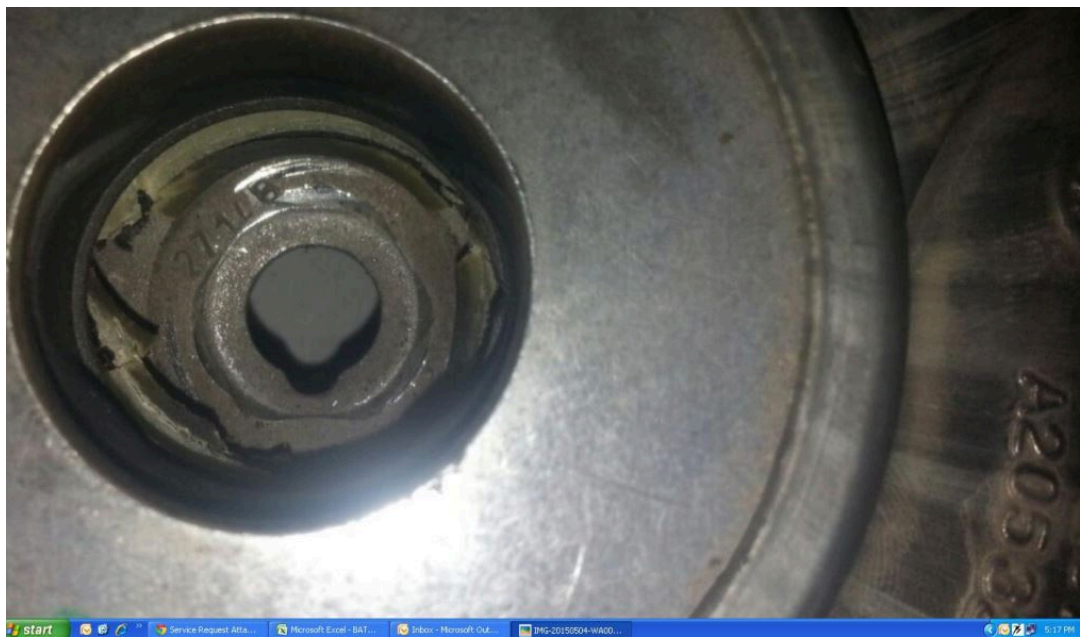
defektes Kopflager.jpg:

| Attachments | |
|---|---|
| defektes Kopflager.jpg | Cracked support bushing |

The plastic core may detach from the rubber mount and possibly make noises.

Installation of modified support bushing with steel core insert.
