## MBUX multimedia system: Vehicle position on navigation map inaccurate/route guidance inaccurate

| Topic number | LI82.85-P-070427 |
| Validity | Model series 253 with code 548/549 and 365 |

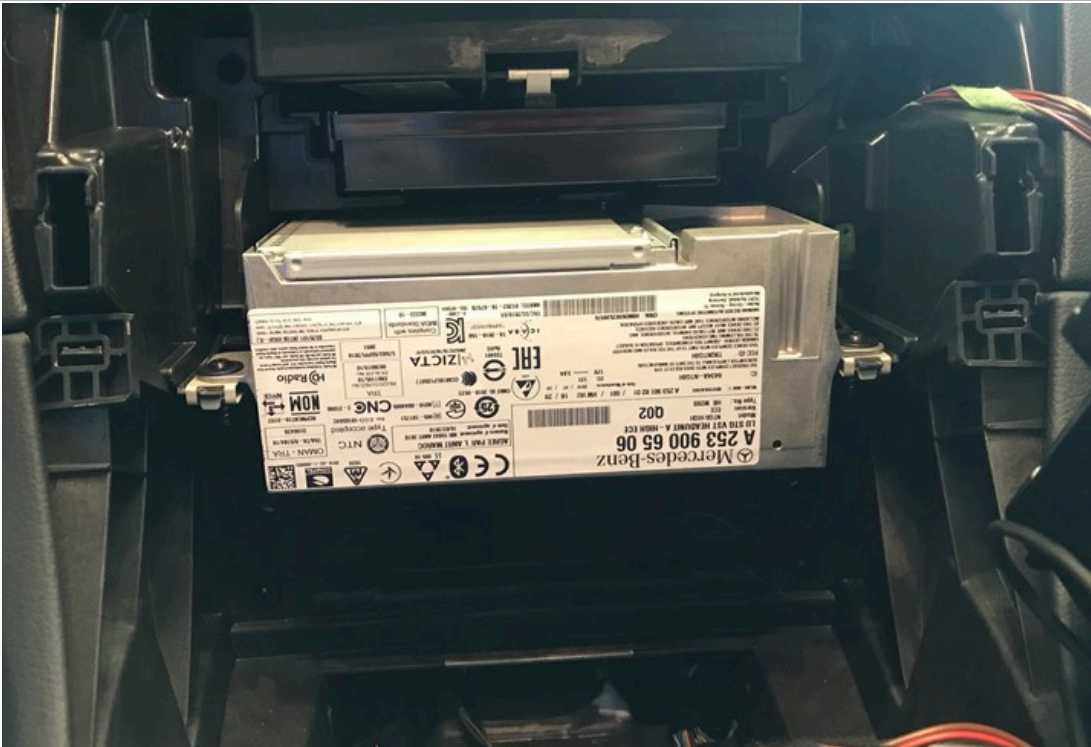
253 correct MBUX installation.jpg:

Incorrect positioning of the MBUX multimedia system (A26/17)

| Attachments | |
|---|---|
| 253 correct MBUX installation.jpg | Correct MBUX multimedia system installation position |

Check positioning of the MBUX multimedia system (A26/17) and correct if necessary (see attachment for proper positioning, NOTE: label may be upside down when positioned correctly, do not use the label as a reference).

After correcting the head unit installation position, enter "Dealer Mode" by holding down the "Home" button on the touchpad and the "Radio/Media" button on the upper control panel simultaneously. Select "navigation" -> "Reset Positioning Calibration Data".

Then drive the vehicle around outdoors under clear skies to allow the head unit to recalibrate the vehicle's position.
