# Abnormal Buzz/Groan Noise at 20 - 30 mph From Front Transfer Case

YEAR(S)	MODEL(S)	ADDITIONAL INFORMATION
2019 - 2020	RAV4

The information contained in this bulletin supersedes Service Bulletin No. T-SB-0065-19.

Some 2019 – 2020 model year RAV4 Adventure and Limited grade AWD vehicles may exhibit an abnormal buzz/groan noise from the front transfer case at 20 – 30 mph when accelerating from a stop and/or at 20 – 13 mph on deceleration after driving the vehicle for 15 – 20 minutes or more. This condition occurs with Normal drive mode selected during disconnect/connect timing of the AWD system. Follow the Repair Procedure in this bulletin to address this condition.

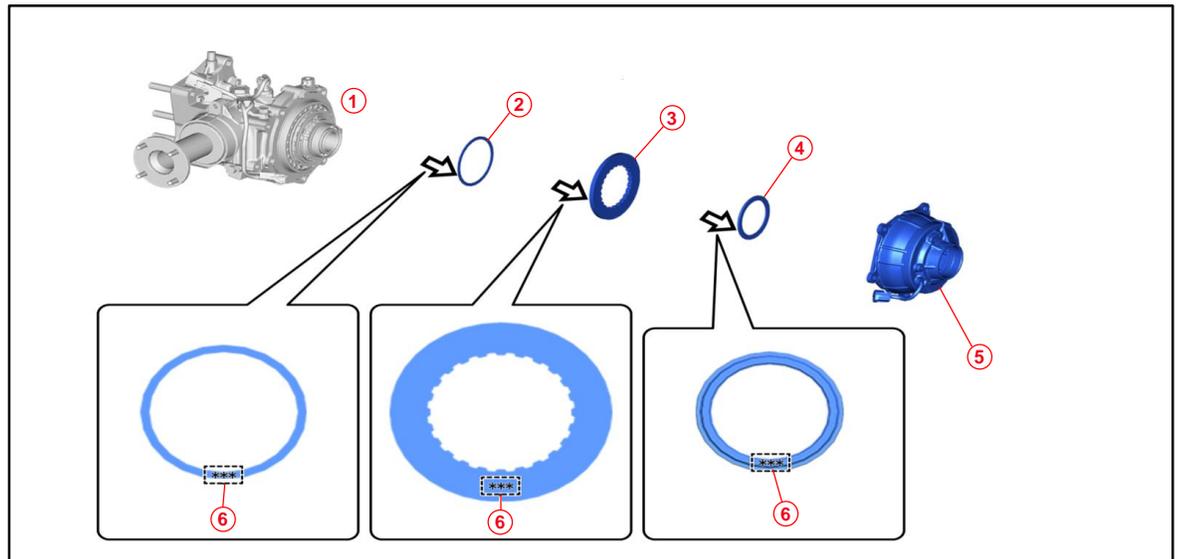
**Figure 10.**

A NEW shim, armature plate, and thrust roller bearing MUST be installed to the front transfer case with the engraved mark surfaces facing the vehicle inner side (automatic transaxle side). If engraved markings are visible AFTER installation of either shim, armature, and/or needle bearing, the customer may experience the same buzz/groan noise concern AFTER the repair. Ensure the engraved markings are NOT visible when installing these three components.

<b>1</b>	Engraved Marks Facing Toward Vehicle Inner Side (Automatic Transaxle Side)
<b>2</b>	Shim
<b>3</b>	Armature Plate

<b>4</b>	Thrust Roller Bearing
<b>5</b>	Cover With Outer Plate
<b>6</b>	Engraved Mark

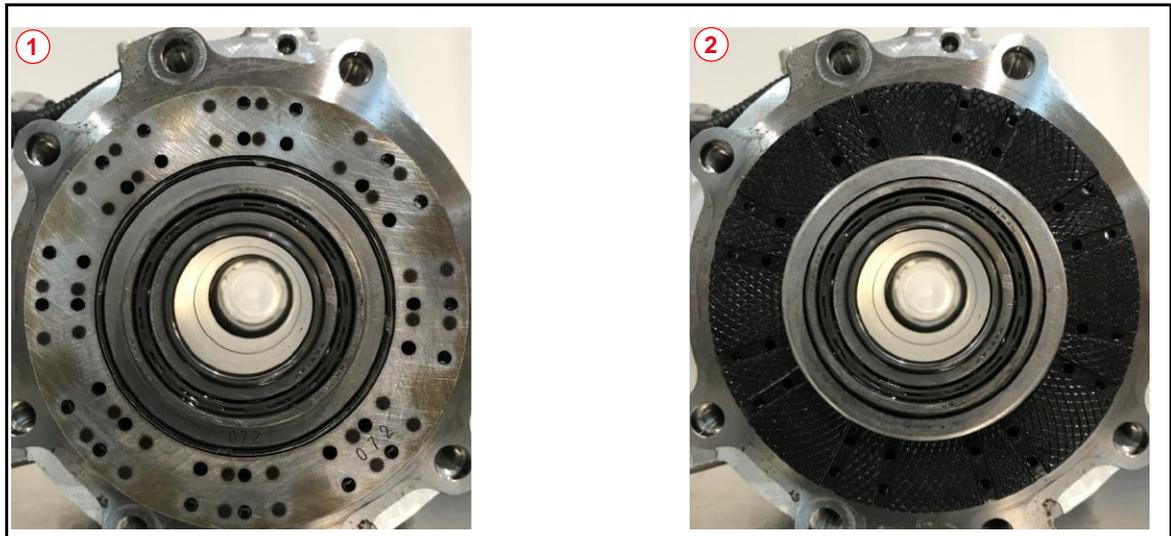
**Figure 14. No Good vs OK Condition**

<b>1</b>	<b>No Good Condition</b>
<b>2</b>	<b>OK Condition</b>
