MODEL
All Applicable
Models with
C-MDPS

NUMBER
084 (Rev 6, 11/25/2020)

TECHNICAL SERVICE BULLETIN

SUBJECT: PARTIAL REPAIR OF C-MDPS MOTOR, ECU, WORM GEAR
AND/OR STEERING COLUMN HOUSING

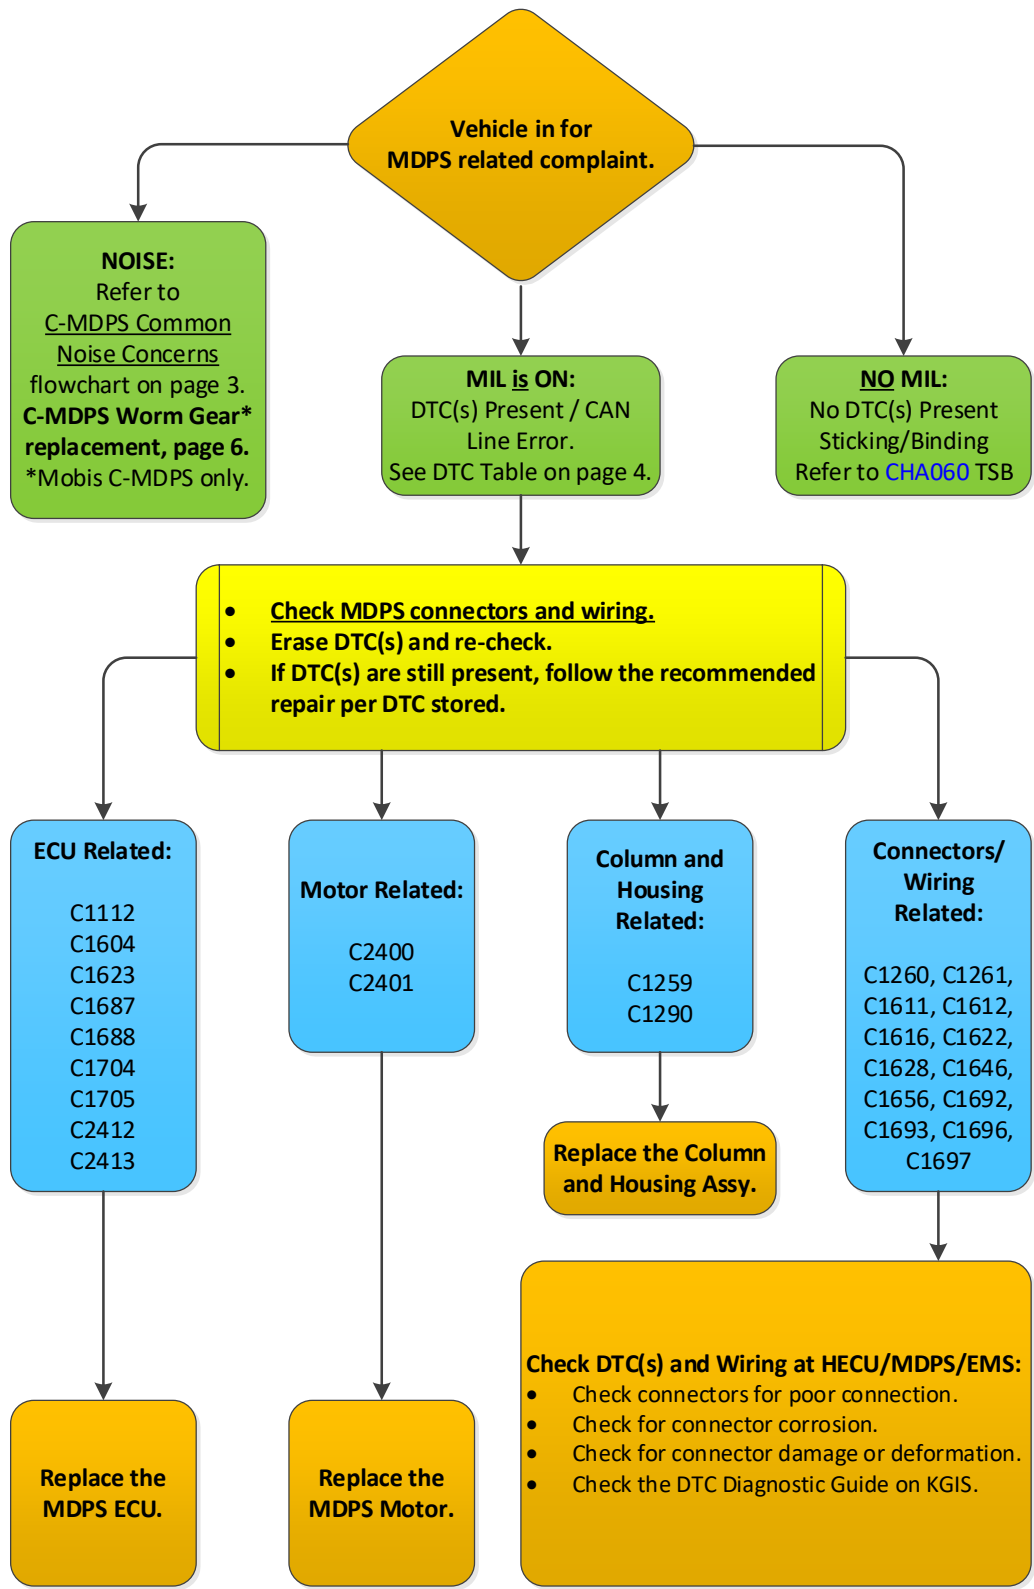
- MDPS Repair Flowchart and Common Noise Flowchart are meant to be used as a reference guide only. See MDPS DTC table for more details.
- Note that some DTC(s) may be found in systems other than Electric Power Steering (EPS) in KDS. They may be found in the Brake/ABS/ESC system. Check all systems for DTC(s).
- Replacing the complete C-MDPS Steering Column Assembly is NOT allowed when the components failure is identified in the flowchart. In addition, replacing the Steering Column Housing is NOT allowed when the problem source is the C-MDPS Worm Gear Assembly (for applicable models).

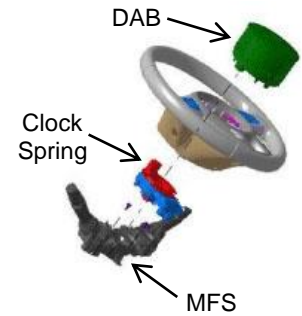
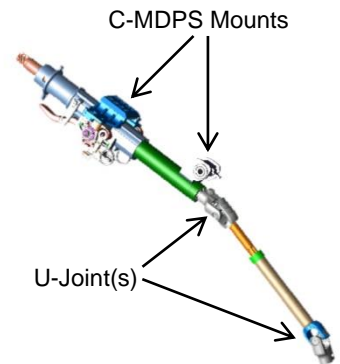
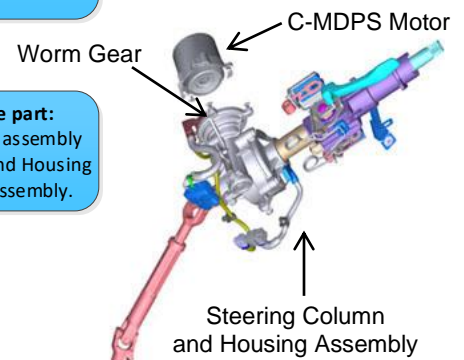
Video: Worm Shaft Bearing Noise

7. Check C-MDPS
Noise present from the column and housing
Noise present from C-MDPS motor
Noise from C-MDPS Worm Shaft Bearing

Replace defective part:
C-MDPS Worm Gear assembly
or Steering Column and Housing
or C-MDPS Motor assembly.
