MODEL  
2020-2021MY  
Telluride (ON)

NUMBER  
213 (Rev 1, 11/12/2020)

## TECHNICAL SERVICE BULLETIN

**SVM/AVM CAMERA DISPLAY IMAGE QUALITY  
AND TPMS LIGHT ON**

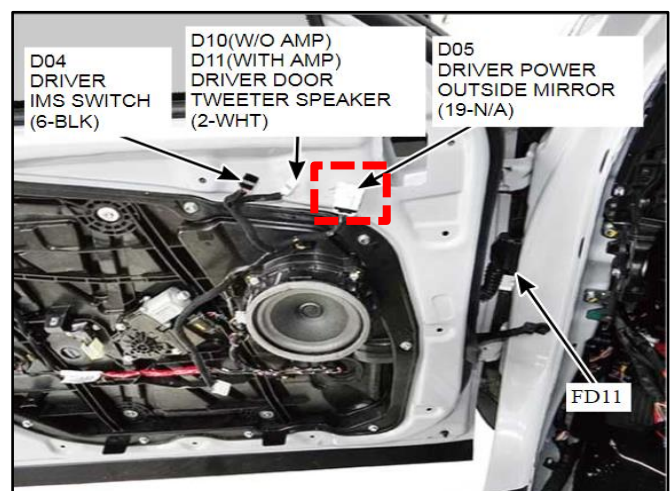
4. **Driver side door:** Locate the **D05** connector in the upper right side of the doorframe. (Refer to image)

**Passenger side door:** Locate **D25** in the upper left side of the doorframe.

Disconnect the connector and use the mirror side of the connection when completing the next few steps.

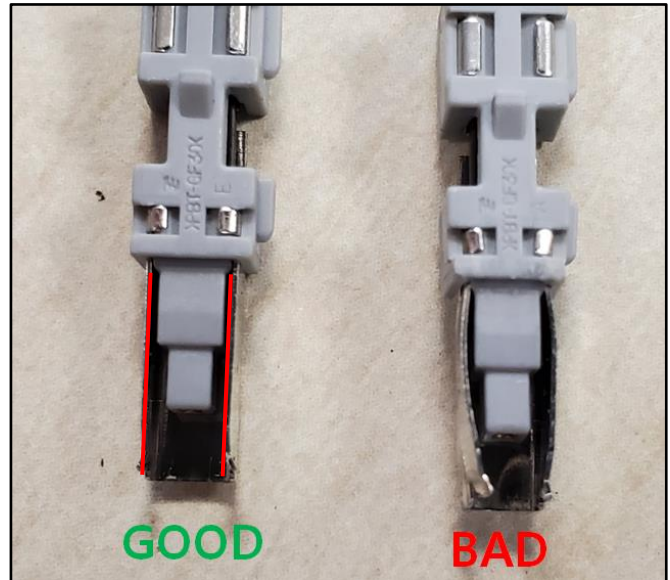
- 7a. Inspect the coaxial connector.

**Note:** The walls need to align parallel and evenly spaced.

Adjustment of 0.10~0.15 mm is recommended. To gauge proper adjustment, there will be a noticeable improvement in connection tension when mating male and female coaxial connections after adjustment is made.

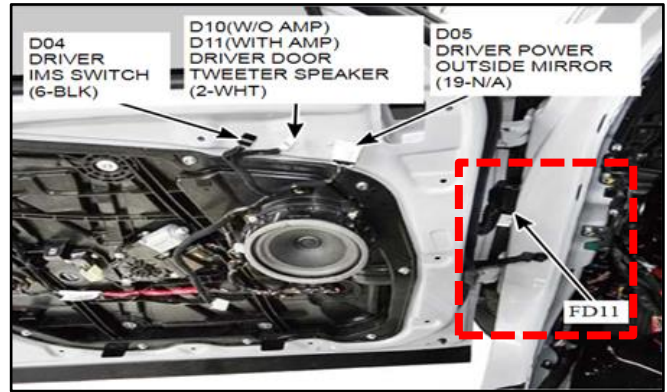
- 9a. **Driver side door:** Locate the **FD11** connector in the upper right side of the doorframe. (Refer to image)

**Passenger side door:** Locate **FD21** in the upper left side of the doorframe.

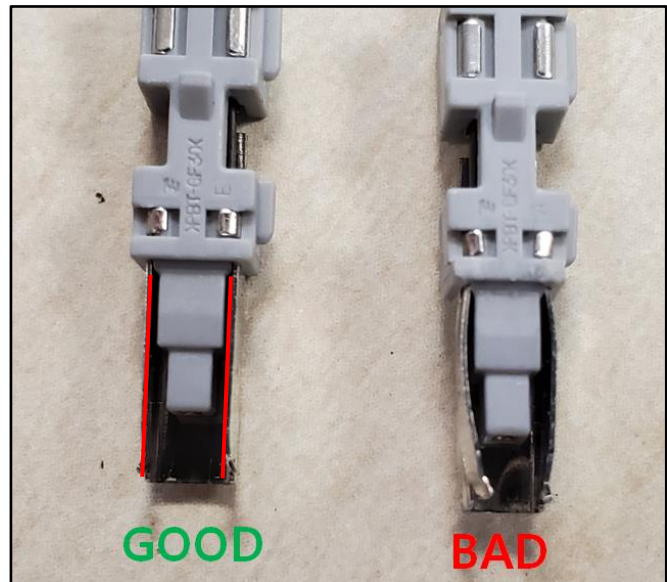
13. Inspect the coaxial connector.

**Note:** The walls need to align parallel and evenly spaced.

Adjustment of 0.10~0.15 mm is recommended. To gauge proper adjustment, there will be a noticeable improvement in connection tension when mating male and female coaxial connections after adjustment is made.

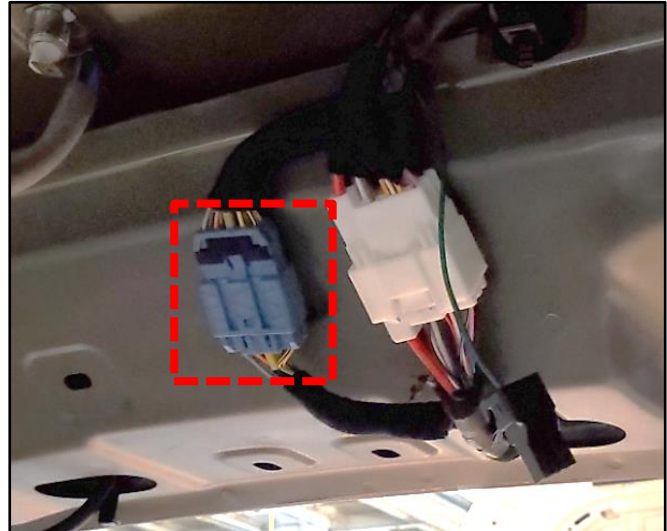
4. Access the **FR21** connector (blue) in and disconnect it from the mating end. The floor harness side of the connector has the female terminal that must be removed.

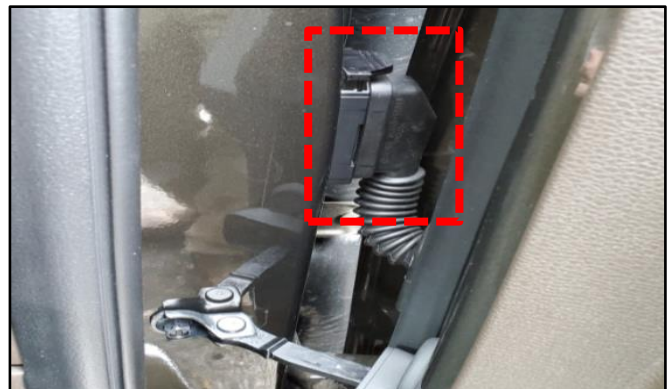
2. Locate the **FD21** connector located between the passenger door and body

3. Refer to pages 5-7 (steps 9b through 15) for removing the coaxial terminal and improving the terminal tension.
