## Mack Chassis - Granite (GR) - Intermittent Or Inoperative Headlights, Front Marker Lights, Turn Signals, And/Or Plow Lights

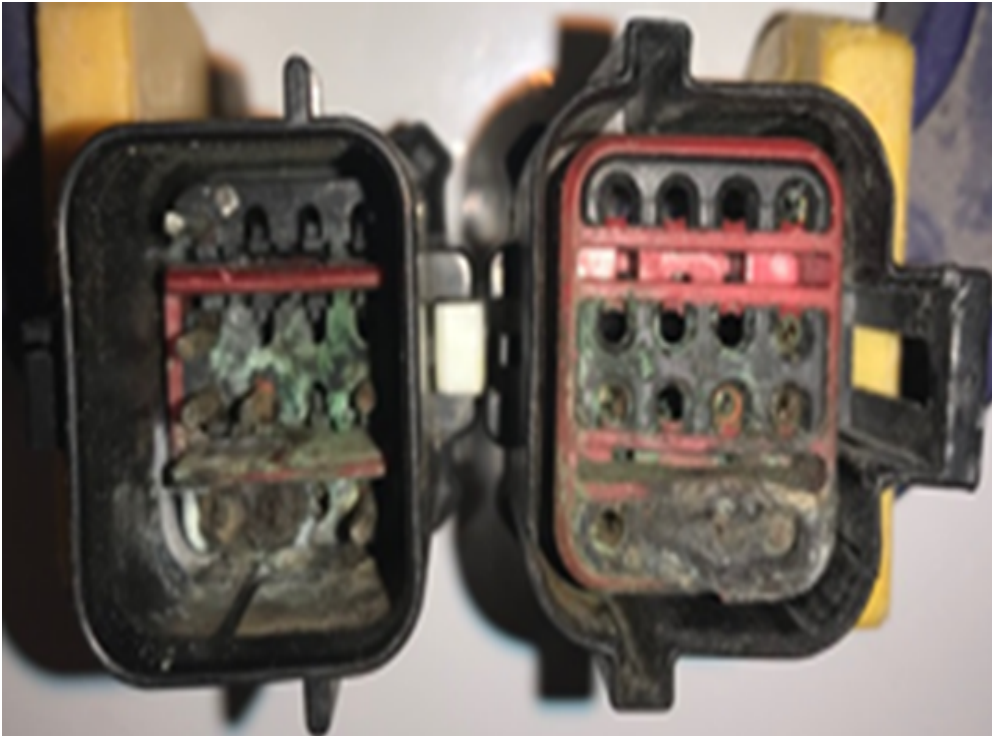
Some Mack GR models built between January 29, 2018 and October 25, 2020, especially when equipped with a snow plow, may experience corrosion inside the front chassis to headlight harness connectors. The location on the framerail can be susceptible to roadspray, ice, and snow packing onto the connectors.

Brackets are available to relocate the connectors from the framerail to the radiator supports. Relocating the connectors will require the harnesses to be lengthened with pigtailed. See parts list below.
