TECHNICAL SERVICE BULLETIN

10R140 Transmission – Ticking Or Scraping Noise Coming From Bellhousing - Built On Or Before 7-Nov-2020

20-2408
25 November
2020

Ford 2020 F-Super Duty

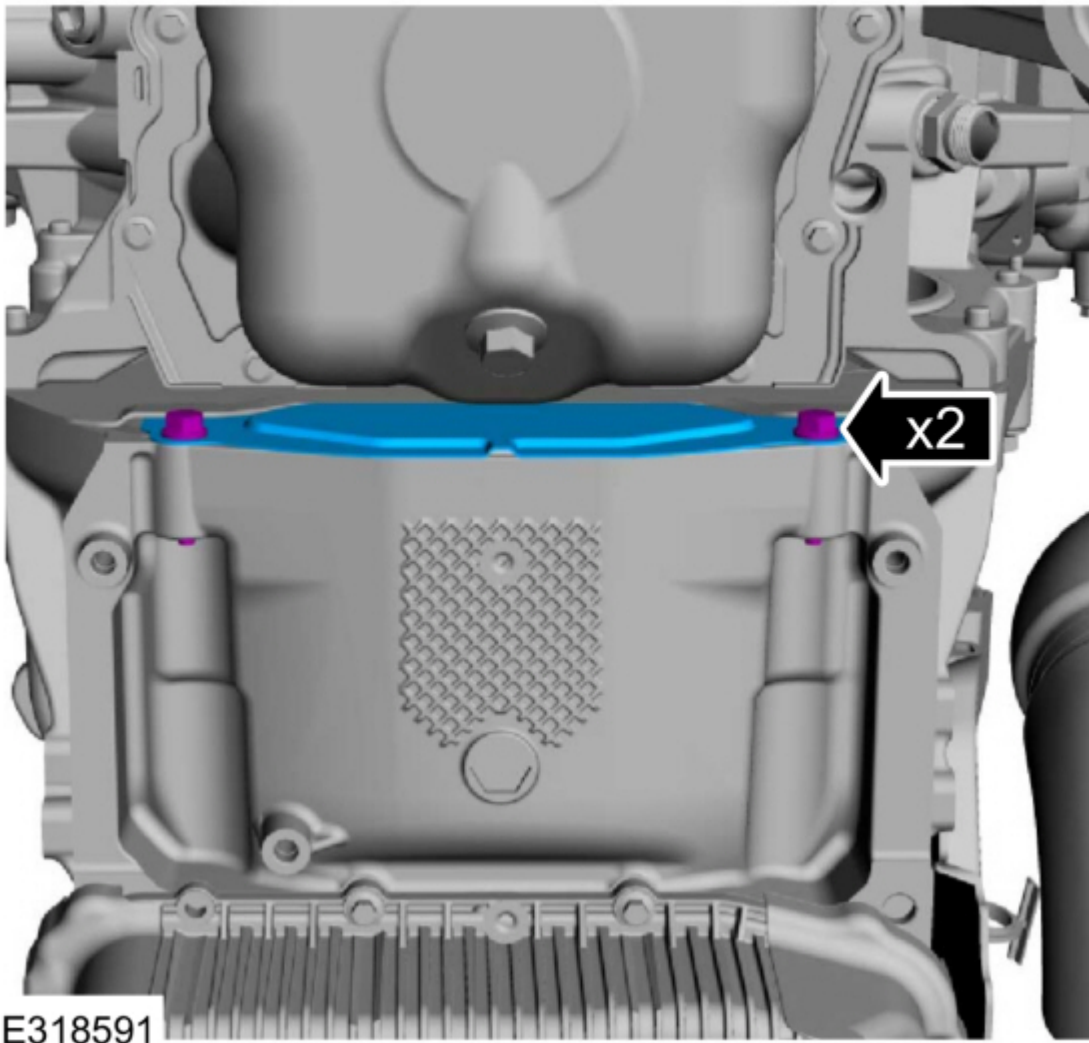
Issue: Some 2020 F-Super Duty vehicles equipped with a 10R140 transmission built on or before 7-Nov-2020 may exhibit a ticking or scraping noise coming from the bellhousing. The noise may or may not go away while in PARK and/or NEUTRAL. This may be due to the torque converter studs contacting the flexplate inspection cover and/or internal torque converter damper spring contact. To correct the condition, inspect and adjust the flexplate inspection cover (gas engine only) and/or replace the torque converter (gas or diesel engine).

- (1). Yes - remove and inspect the flexplate inspection cover for contact with the torque converter studs. If contact is found, adjust the cover so contact does not occur. Refer to Figure 1.
- (2). No - proceed to Step 3.
