# Technical Service Bulletin

**01 Car jerks/bucks or hesitates while driving DTCs P023400, P023500, P023600, P023700, and P023800 are stored in the ECM**

01 20 94 2058976/4 November 24, 2020. Supersedes Technical Service Bulletin Group 97 number 20-76 dated June 12, 2020 for reasons listed below.

Model(s)	Year	VIN Range	Vehicle-Specific Equipment
Q5	2018 - 2020	All	2.0 liter

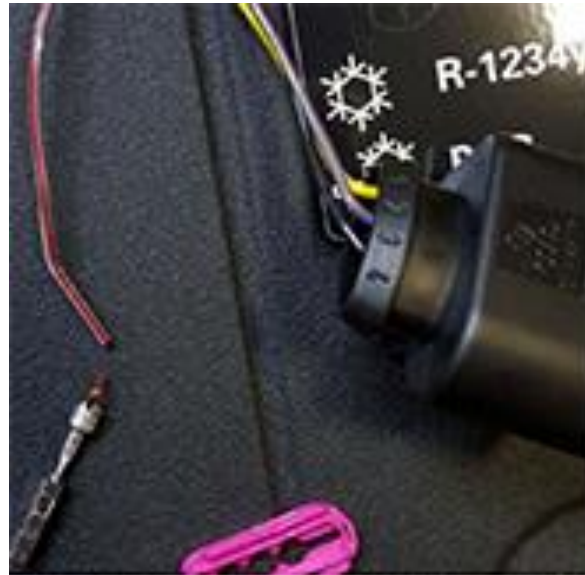
One of the pins or wires at the boost pressure sensor (G31) connector T4e may be backed out or broken due to the routing concept of the engine harness. When inspected, the harness is found to be too tight in the area of the sensor.

*Figure 1. T4e with damaged wire.*

If there is damage to the pins or wire, repair the harness as needed (Figure 1). Ensure there is sufficient slack in the harness to prevent future issues.
