Technical Service Bulletin

13 Starter/generator drive belt is noisy or came off, DTC P2BA300 may be stored in the ECM

13 20 10 2061461/1 November 24, 2020.

Model(s)	Year	VIN Range	Vehicle-Specific Equipment
A6	2019 - 2020	All	2.0TFSI Hybrid

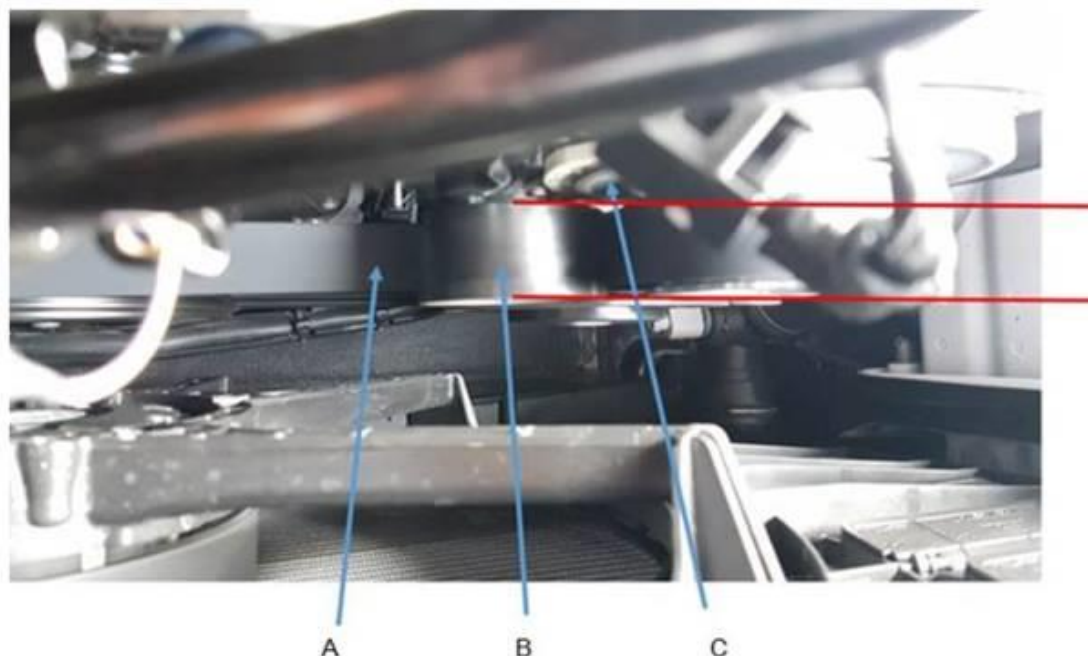
1. Run the engine at idle speed.
2. The belt must not protrude forward or backward over the roller edge of tensioner (Figure 2, red marks).

Figure 2. Check to ensure that the poly V-belt is not protruding in either direction.

A = poly V-belt.

B = tensioning roller of belt tensioner.

Check for correct belt running alignment after poly V-belt and tensioner replacement as follows:
