# NOx Conversion / DPF Ash Volume

We had Vin FM7189 DD15GHG14 come in on Friday with active faults

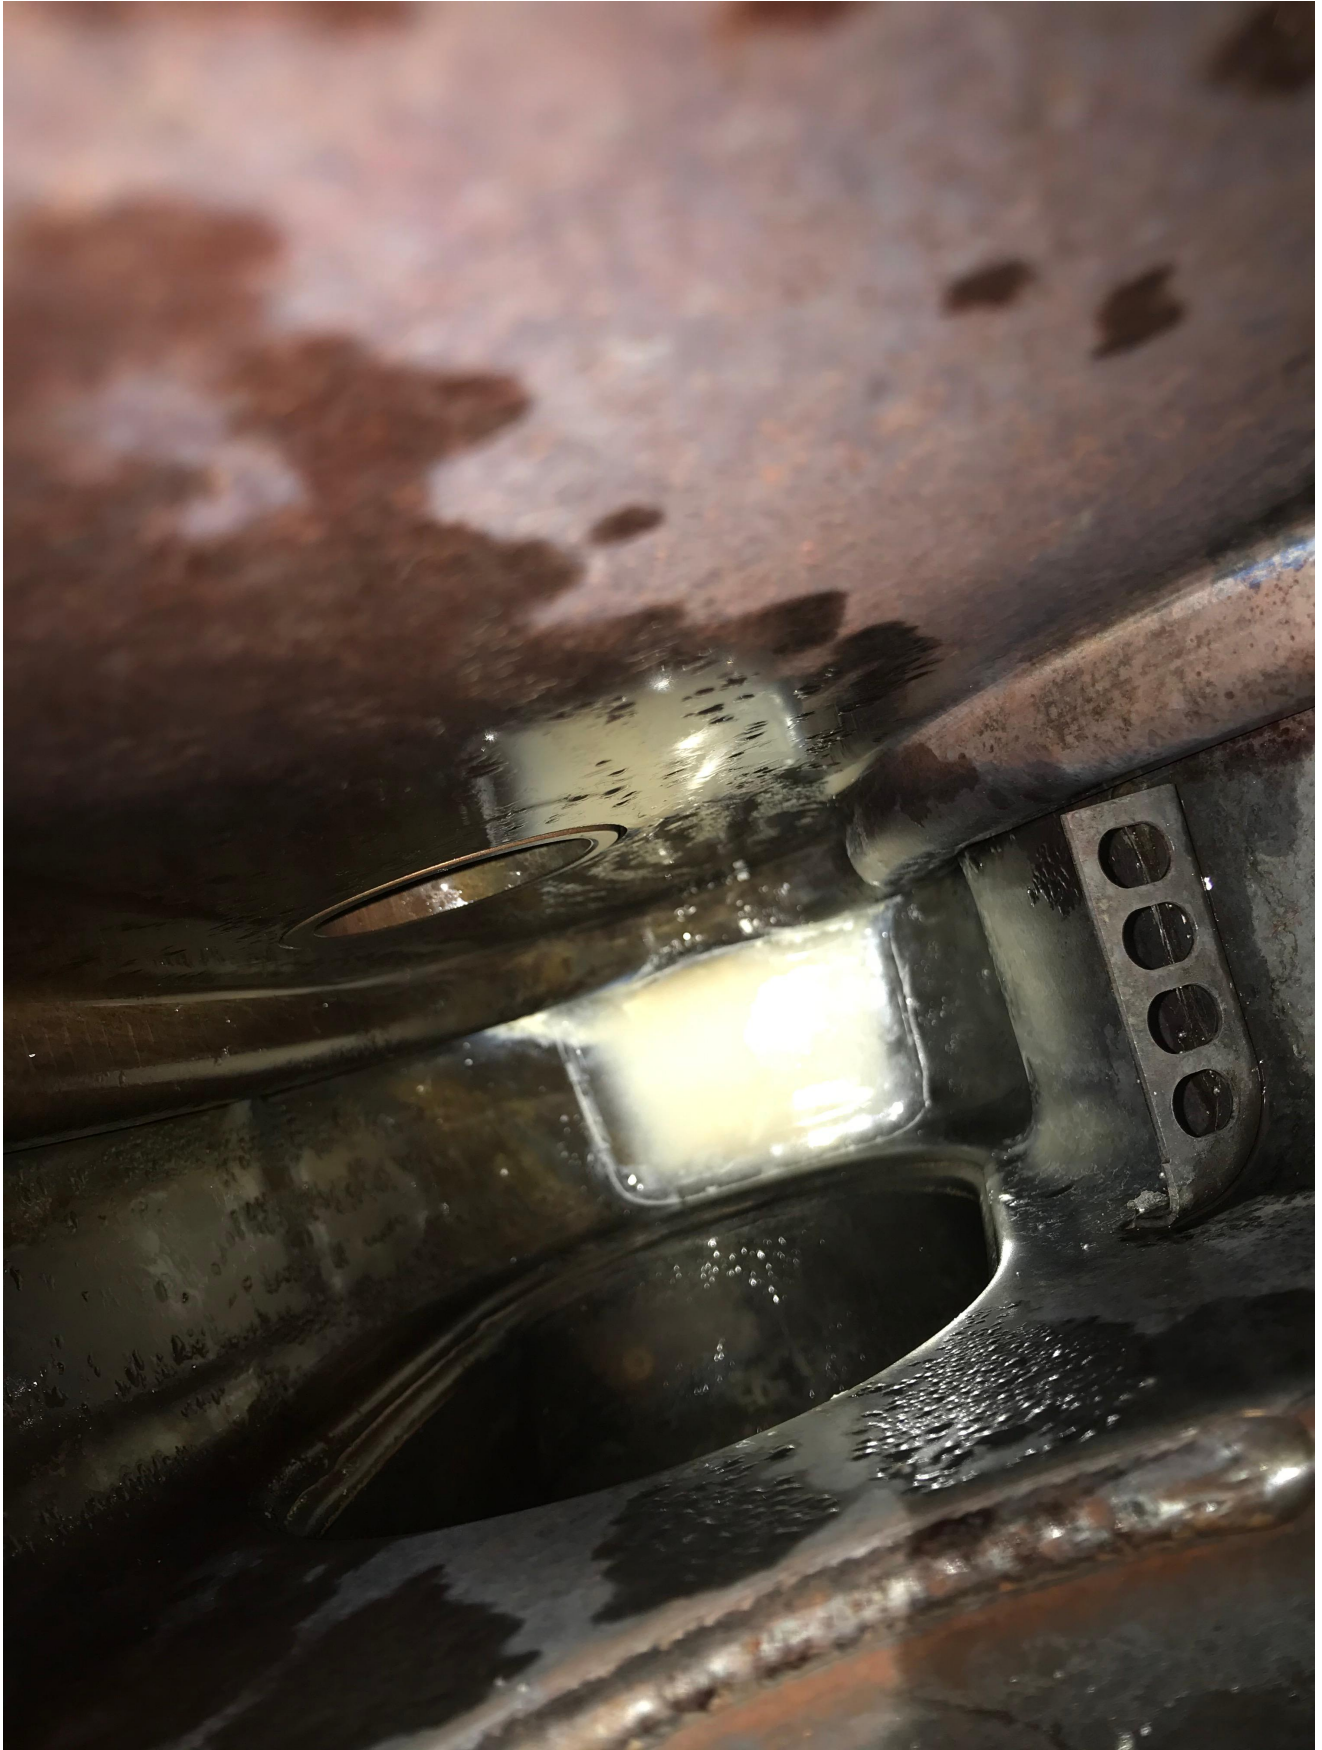
Vin: FM7189 - Pulled DPFs - questionable fluid staining. More interesting find - Inside bottom of OneBox, 3-4" of white liquid. Pulled sample - No Coolant, No Fuel - Refractometer shows water - No urea. Double checked DEF quality in tank and it is spot on at 32.5%. Let sample from inside OneBox sit overnight - No crystals, water evaporated leaving behind a silky white powder (talcum consistency) OneBox still has 2 - 2.5" of fluid inside this morning. DPFs left wet spots on workbench indicating moisture in filters. Anyone seen this? Thoughts?

Fluid & Moisture in One Box

The fluid looks like oil mixed with water, I think The specified item was not found. has a good question does the fluid feel slippery? I think we are both wondering if the engine is using any oil?
