ABS trailer code 520216 31 P4 New Cascadia Jul 2, 2020 9:36 PM

We have been receiving multiple ABS complaints on newer P4 new Cascadia's for trailer ABS. The re-occurring code that every truck is having is 520216 31, ESC function is reduced (trailer ABS not OK) condition exists. Wabco info is short and sweet, saying faulty ABS functionality. Trucks have ranged from 19k, 41k miles etc and upwards. Operators that pull multiple/different trailers have come in, not specific to a truck with same route/trailer. Two trucks in question, also present with the 629-11 code, are really new P4's too, (19,805 miles) and these two units happen to have a seven way cord that does not ground to the cab back wall. Instead routes under the headache rack, under the left side cab and grounds to a frame stud. Ground load tests from the seven way cord end have always been successful, and no other problems like dirty frame connections. This 520216 does not effect truck ABS but the display does not tell the driver that, they perceive that they have a truck ABS problem instead, often times dropping the current trailer and bringing to the shop.

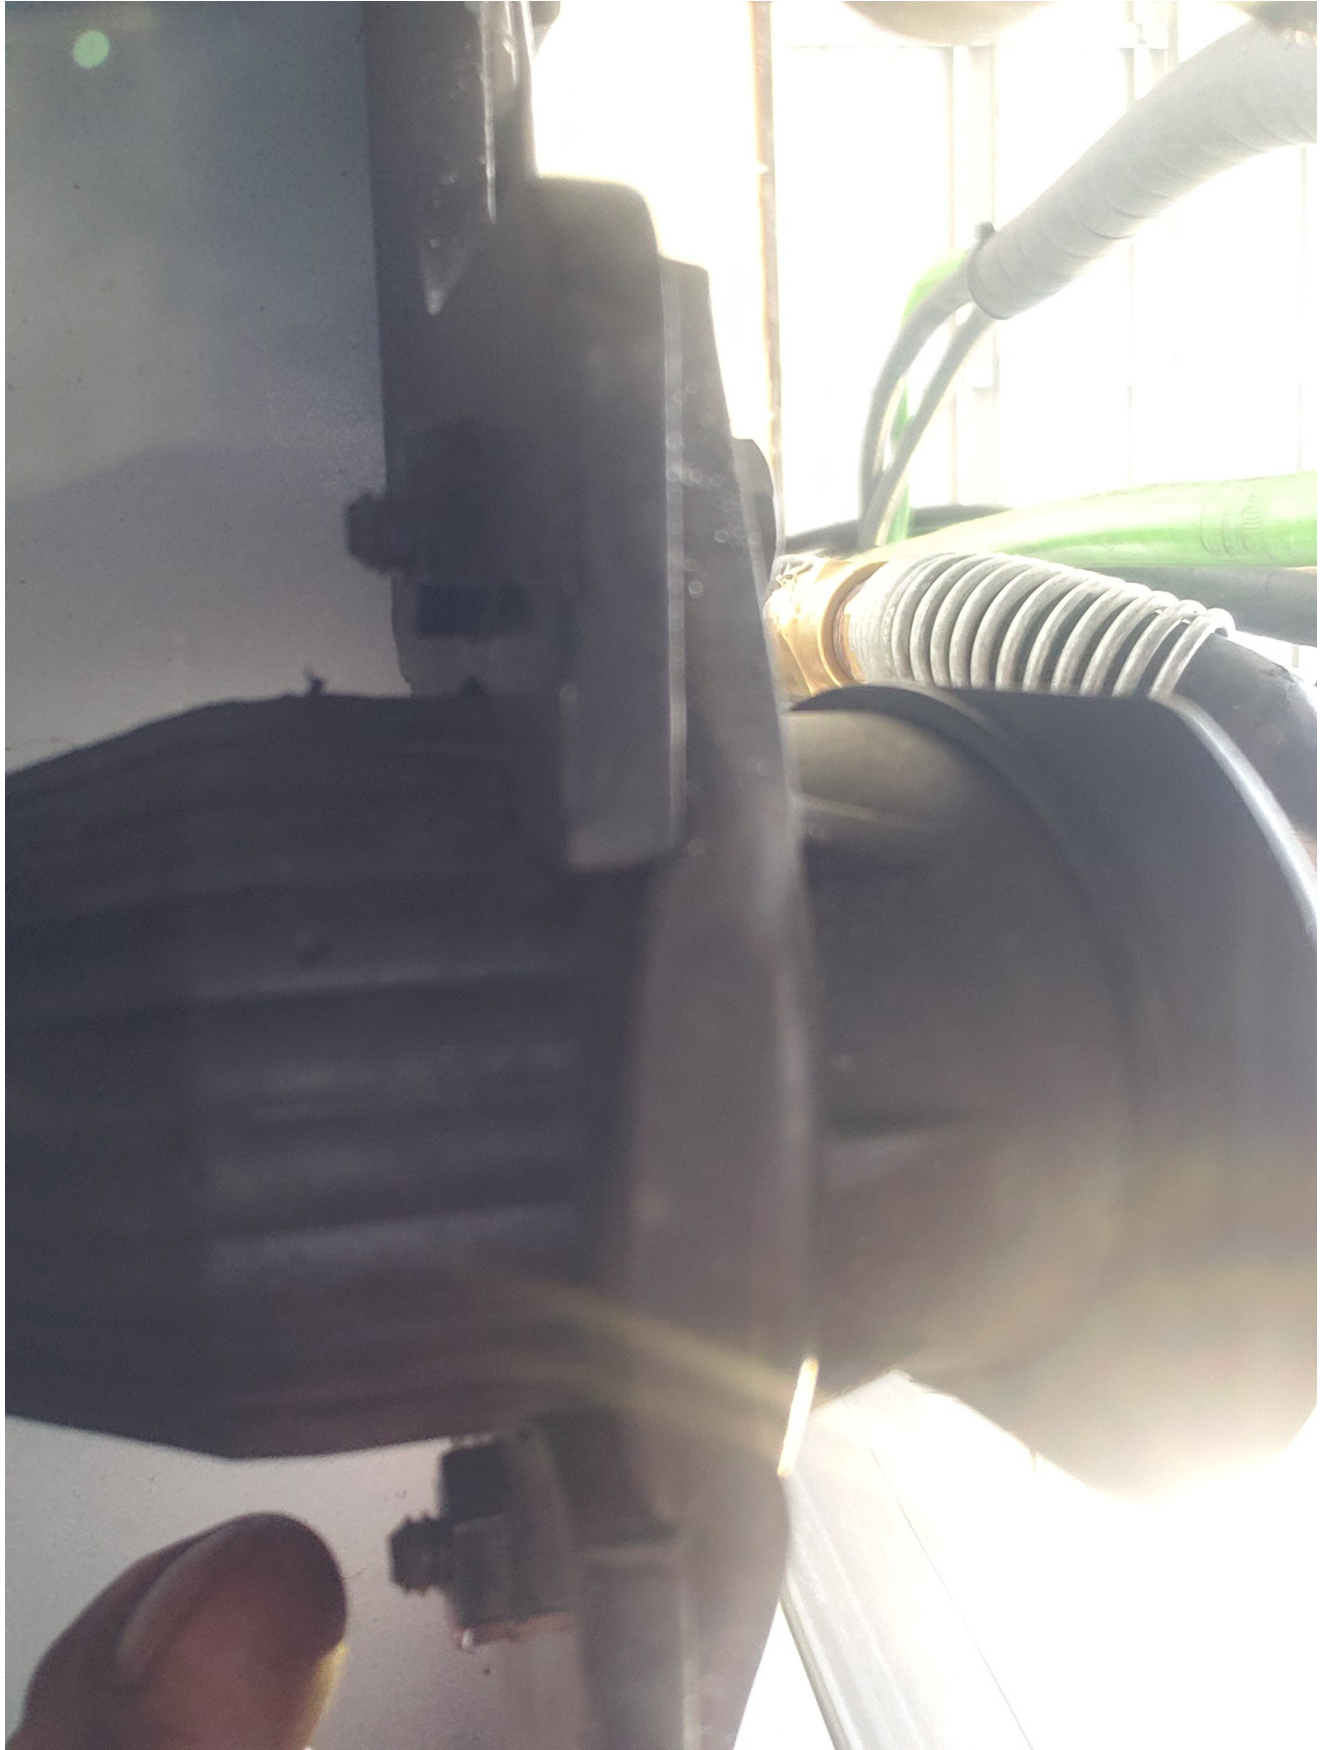
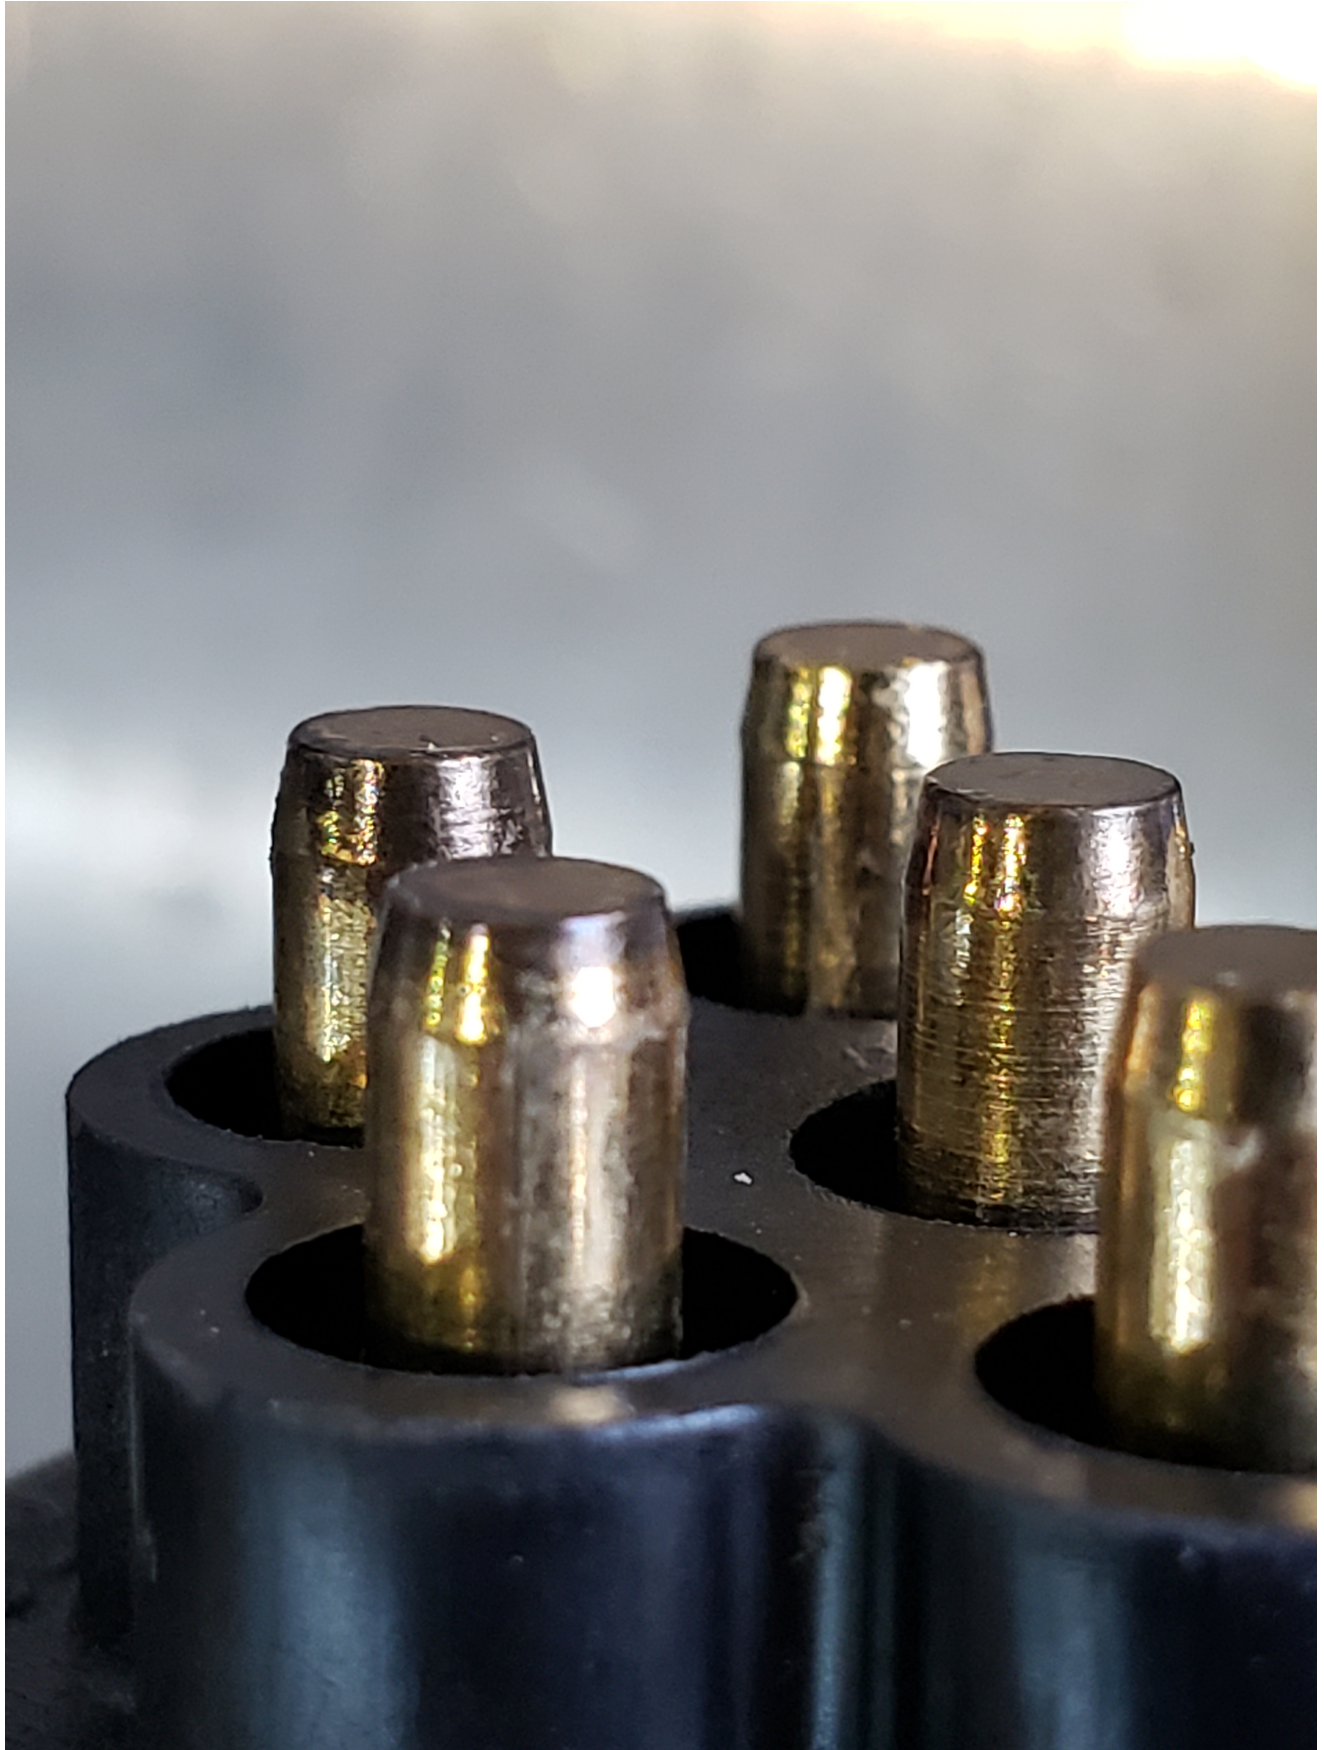
Has any body had a verified successful repair with this issue? I noticed something not mentioned in any of the talk aside from possibly a bad 7 way cable. I have seen this issue before when customer would replace the primary receptacle with the incorrect type and trailer lighting problems would occur. Is it possible we are overthinking this just because it is a P4? I took the primary receptacle off the back of the cab and now I am thinking it was not tight. When I first went to take it off, I felt on the inside of the plate to see if there were nuts on the other side or rivet nuts. I don't remember the bolt sticking through the back side of the bracket. When I inspect the primary receptacle and the trailer cord, it doesn't look like they are making full contact as seen by the wear patterns.

I can't say for certain as all ABS faults are inactive when it came in, and I was just checking things over. this is a local run truck, so I'm sure they will be back if this didn't correct the issue.
