# MOTORHOME VIN # LJ4372.

**MOTORHOME VIN # LJ4372.** Sep 16, 2020 7:44 PM

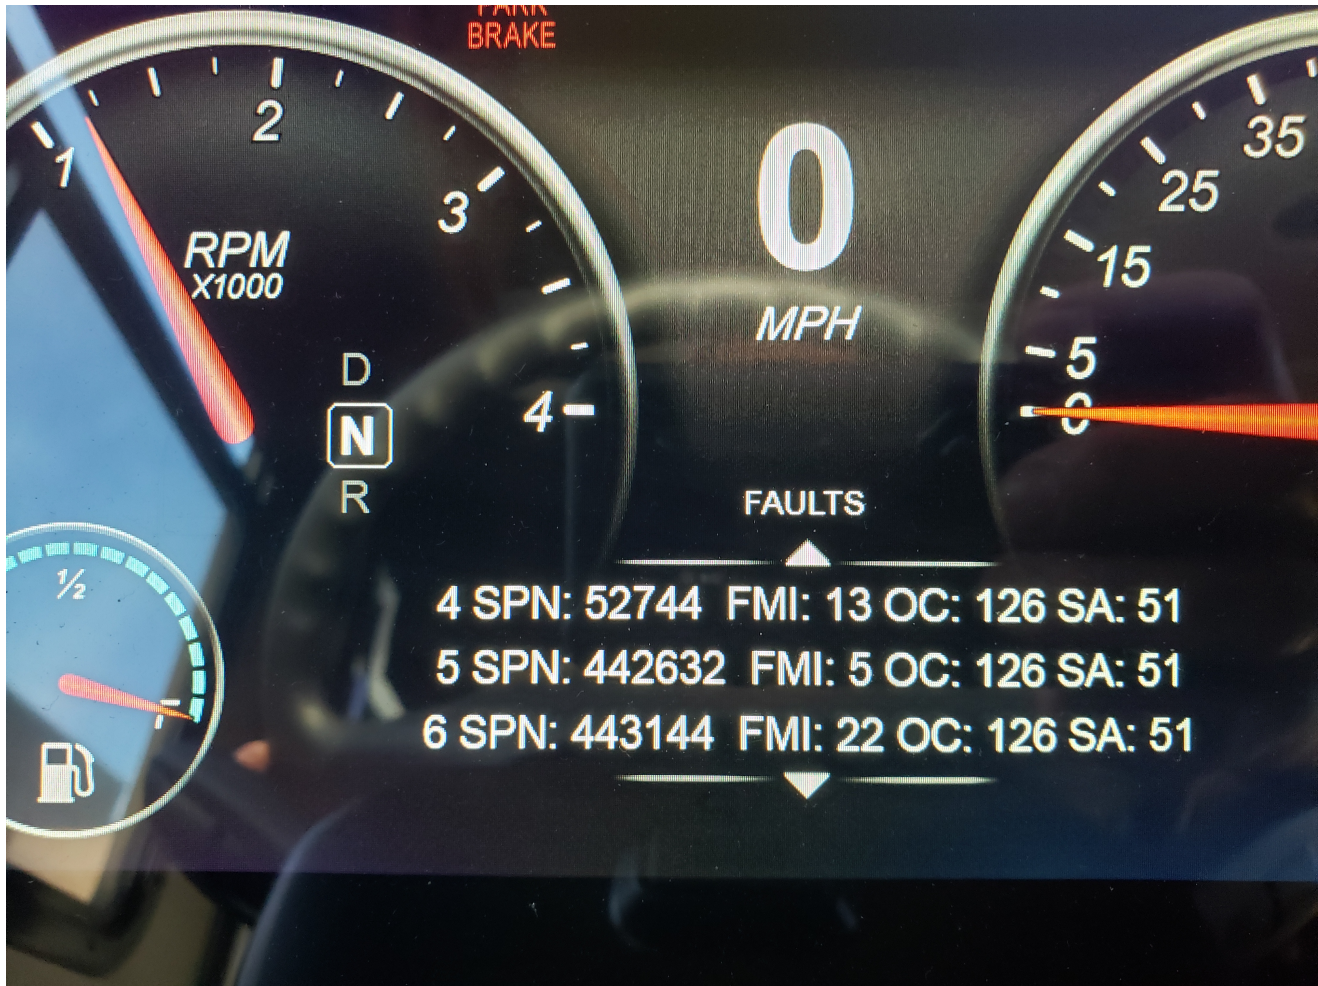
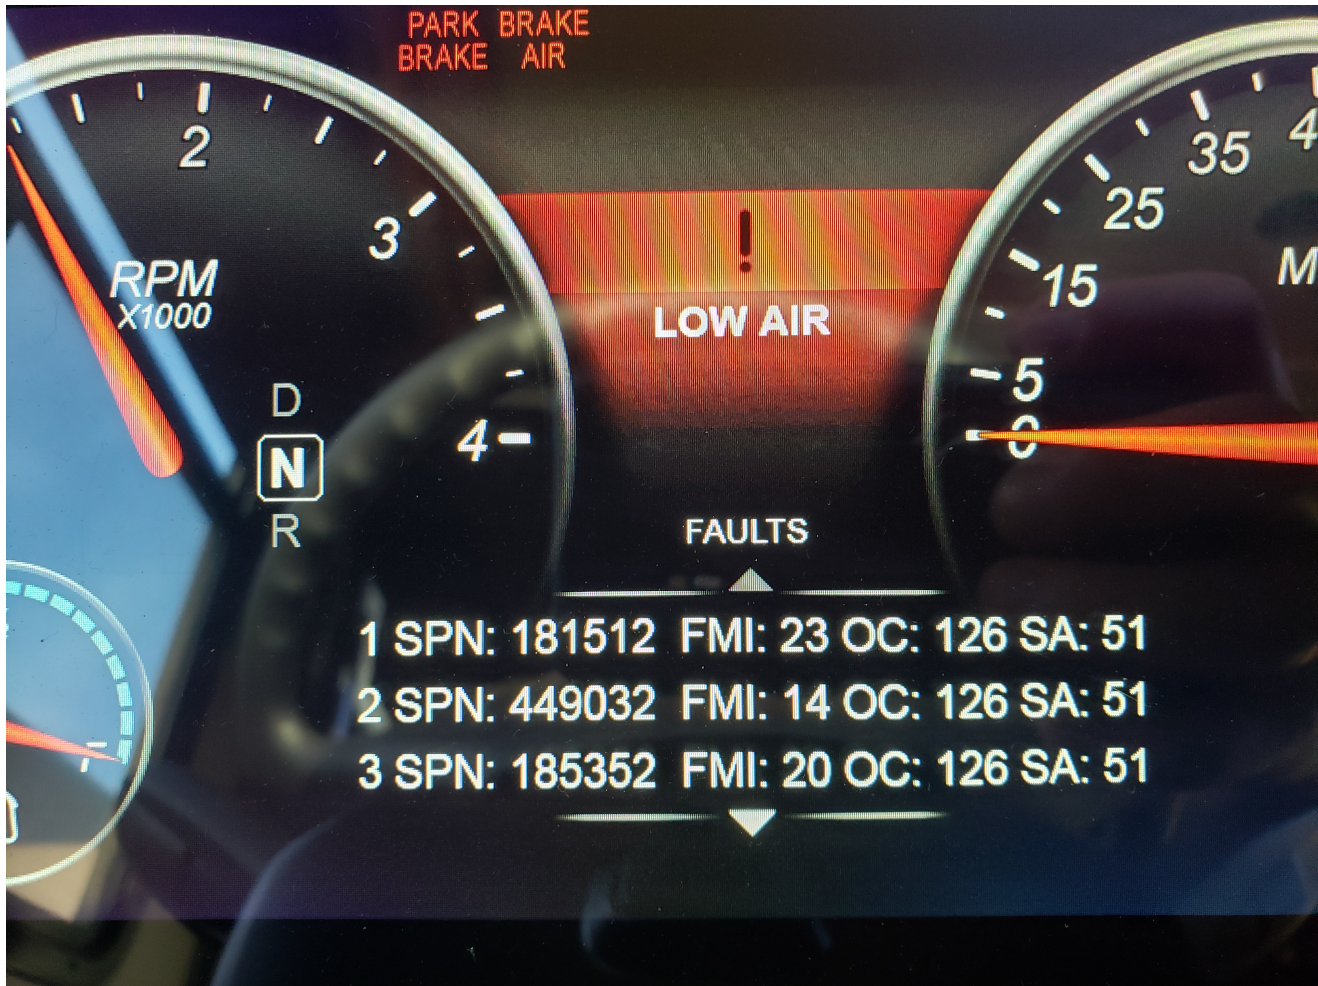
I checked codes with DL and the codes flash so fast I can't even keep up with them. What's weird is DL doesn't show them as being inactive or active, it's almost like a scrolling list. The ICU shows TPMS communication error and there are 6 different faults listed when going to diagnostics tab I did some research and agree with some of the other posts. Valor doesn't really give a fault code troubleshooting in their manuals.

I scrolled through the dash to retrieve the active TPMS faults. I looked at TS1033423 for J1939 fault identifier. The SA is correct. source address 51 is TPMS. But the SPN and FMI are not found. I even stumped Google with the search. Bottom line is we have to purchase the tool

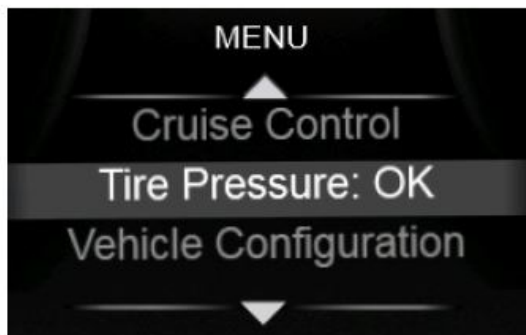
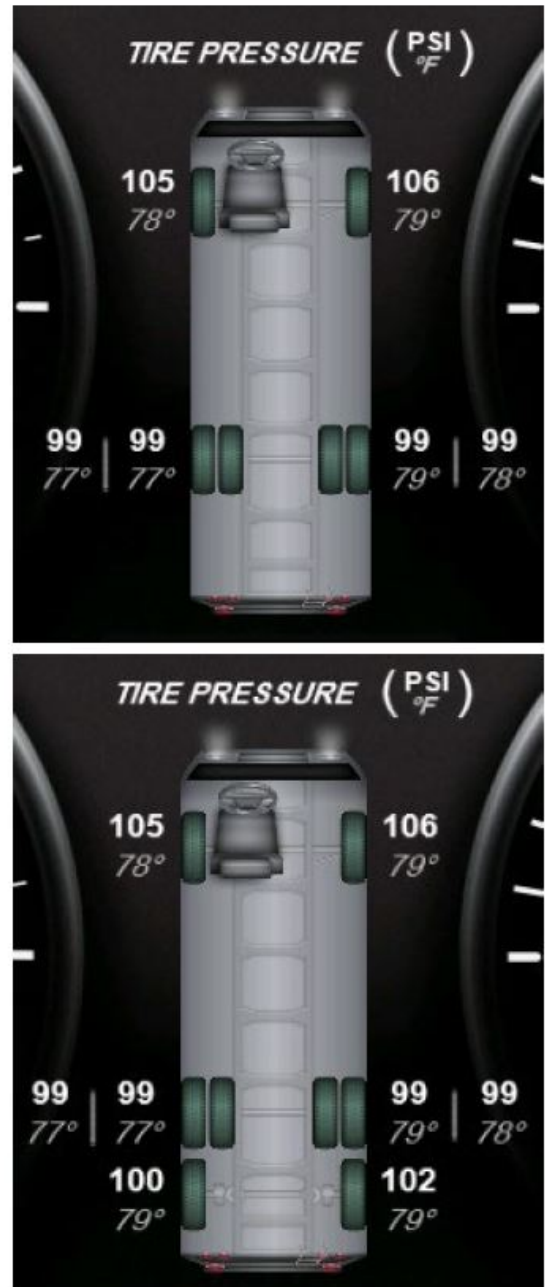
# TIRE PRESSURE MONITOR SYSTEM

The TIRE PRESSURE MONITOR SYSTEM menu is where the operator can see the status of the tires, including tag and tow vehicle (if optioned in).
