# Technical Service Bulletin

## 46 ABS warning light on, DTC C050200 and/or C050800 is stored in the ABS control module

46 20 19 2061331/1 November 18, 2020.

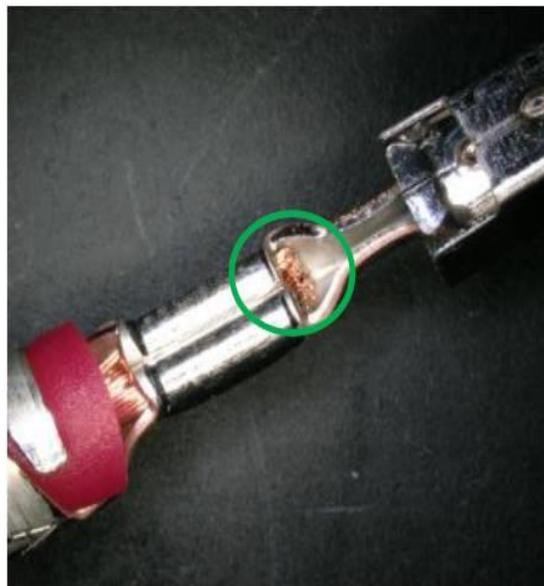
1. Ensure the strands of the wire are protruding past the crimp sleeve (Figure 1).

*Figure 1. Properly crimped wire.*

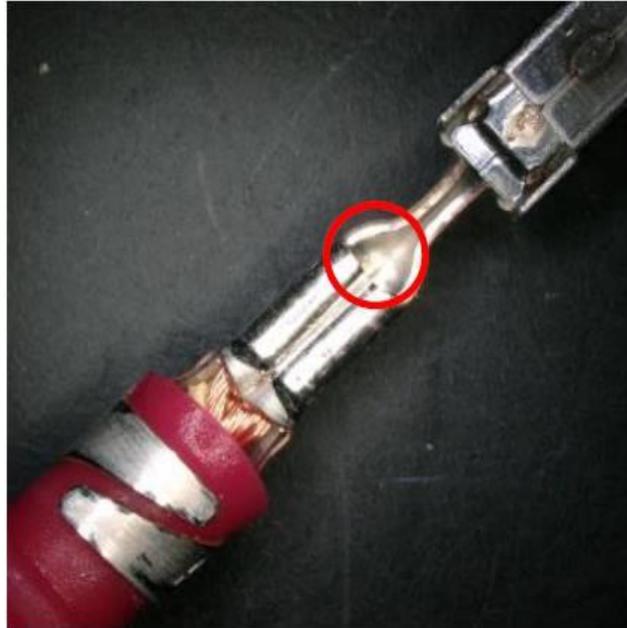
The ABS sensor wire may not be properly crimped to the pin of a front wheel speed sensor connector.

*Figure 2. Improperly crimped wire.*

2. If the wire is found to be improperly crimped, then replace the affected harness for the front speed sensor and brake pad wear indicator (Figure 2).

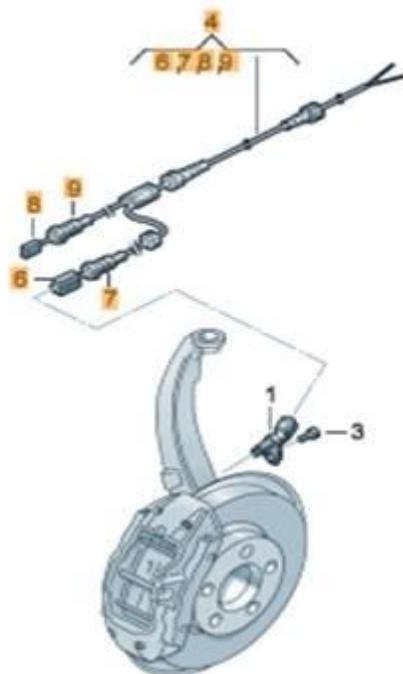
*Figure 3. ETKA image of harness.*

3. ETKA illustration 927-010 can be used to determine the harness needed (Figure 3).
