Technical Service Bulletin

69 Pre sense malfunction warning in DIS, DTCs B130404, B130504, B130408, B130508, B130455, and/or B130555 stored

69 20 60 2059944/4 November 20, 2020. Supersedes Technical Service Bulletin Group 69 number 20-58 dated September 1, 2020 for reasons listed below.

Model(s)	Year	VIN Range	Vehicle-Specific Equipment
Q3	2019 - 2020	All	Not Applicable
Q3	2021	000001 - 004126	Not Applicable

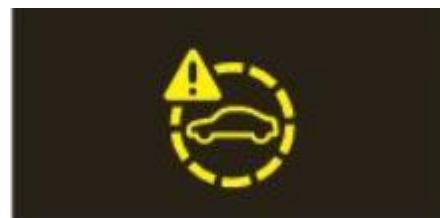
- The instrument cluster is displaying the Pre sense malfunction indicator light (Figure 1).

Figure 1. Pre sense malfunction indicator light.

1. Connect vehicle to ODIS Service and perform GFF.
2. If any of the DTCs are stored in the airbag control module/safety computer follow all applicable GFF test plans.
3. If GFF indicates that the left front and/or right front seat belt tensioner(s) is/are defective, replace the affected front seat belt(s) as outlined in the repair manuals and by following the replacement plans in ODIS Service.
