## FIELD SERVICE CAMPAIGN – 20115

10 November 2020

Body Control Module (BCM)

International® LT® and RH™ Series

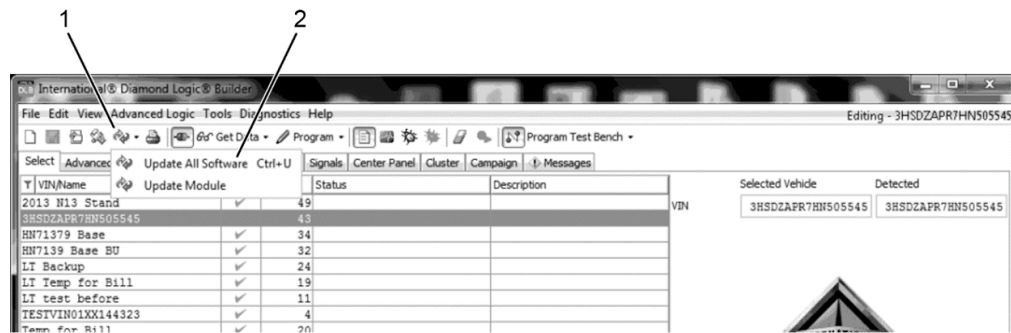
**Figure 1. Update All**

1. Update all icon
2. Update all software

9. Click on UPDATE ALL icon in toolbar (Figure 1, Item 1) and then select UPDATE ALL SOFTWARE option (Figure 1, Item 2). DLB will list latest module versions in Kernel column.

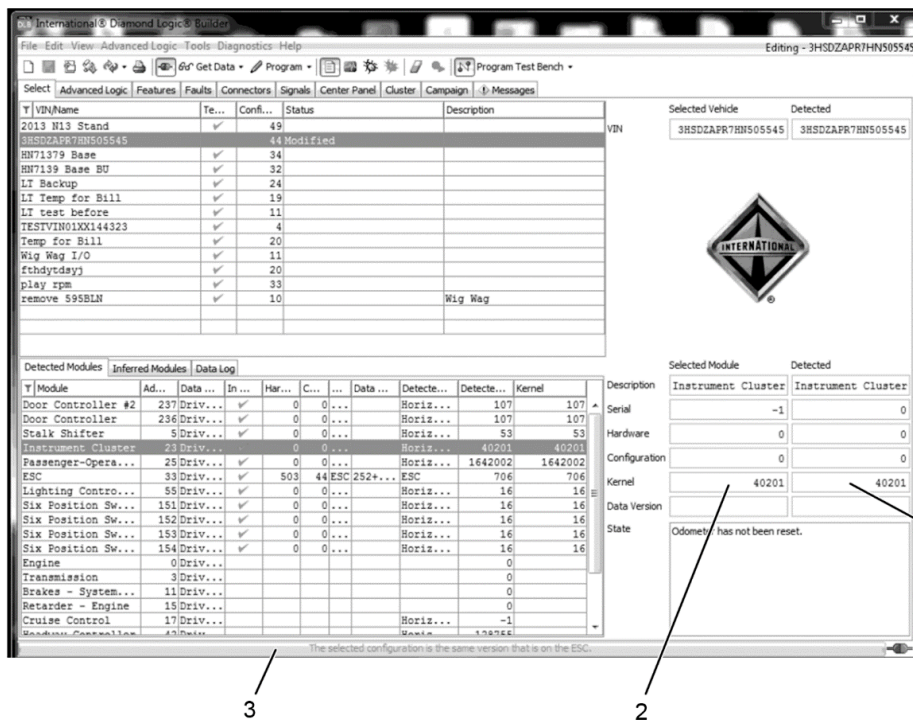
**Figure 2. Programming Complete**

1. Detected kernel version
2. Selected module kernel version
3. Status bar

**NOTE:** When update has been completed for selected module, kernel version listed in Selected Module column (Figure 2, Item 2) will match version listed in Detected column (Figure 2, Item 1). Also, status bar (Figure 2, Item 3) will display message: The selected configuration is the same that is on the ESC.

10. Click PROGRAM icon in toolbar to begin updates. DLB will indicate programming status in status bar located at bottom of window.
