Technical Service Bulletin

91 MIB2+: lower display flickering after a software update

91 20 37 2061029/2 November 17, 2020. Supersedes Technical Service Bulletin Group 91 number 20-18 dated October 15, 2020 for reasons listed below.

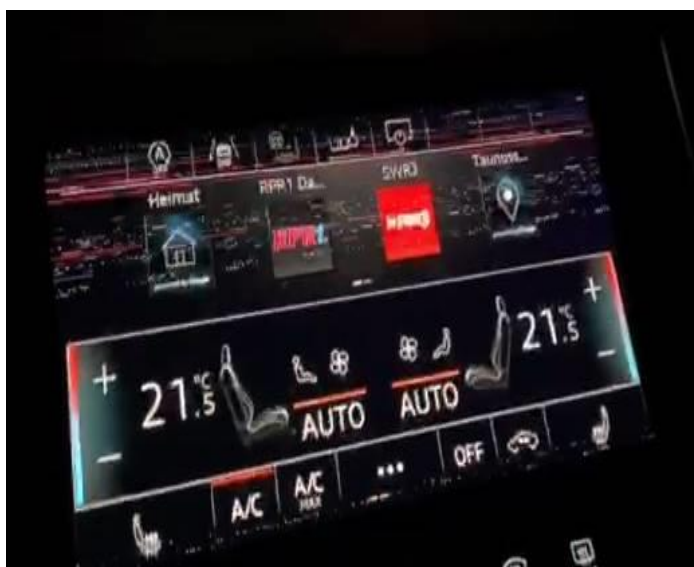
- After a MMI Software update has been completed, the lower display sporadically flickers (Figure 1).

Figure 1. The display sporadically flickers.

There are compatibility issue between the display and MMI software.

The repair described below is only to be performed if the display (address word 0636) has software part number 4K1919605C and hardware part number 4K1919605 with software version 0141.

- Update the MIB2+ display using either Method 1 or Method 2 according to TSB 2056558: *91 MIB2+ Software Update Instructions* and use SVM code 636S002.
