91 Voice recognition performance and Bluetooth call quality issues on other end of the line

91 20 38 2061397/1 November 17, 2020.

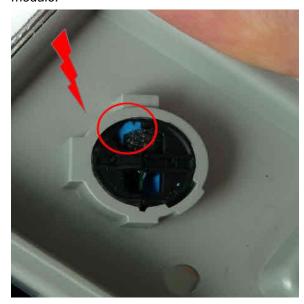
Figure 5. Do not install the microphone on an angle. Always insert the microphone perpendicular to the slot in the dome light module.

2. When installing new microphones, please take care to install them properly as shown in Figures 5-7.

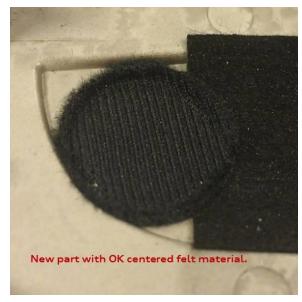
Figure 8. The cloth cover is without blemishes.

- 2. In those cases, smooth the cloth cover until it is fitted tightly without folds or blemishes.
- 3. If the issue outlined in the previous steps does not apply, then continue the fault-finding process according to the repair manual.
