Clicking Noise From Front PCCB Rotors

Revision: **This bulletin replaces bulletin Group 4, #1503, dated August 1, 2019.**

Vehicle Type: **911 Turbo / Turbo S (991)**

Model Year: **2014 to present**

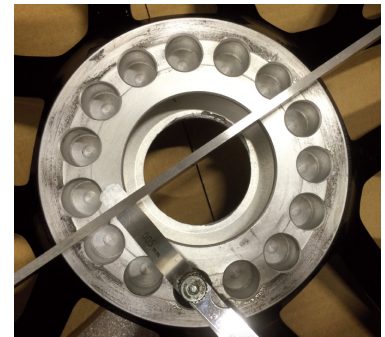
Wheels - Before rotors are replaced, it is necessary to check the mating surface of the wheels with a straight edge (12" Starrett 380) to insure flatness of the surface. Imperfections in the surface may have an influence on the rotor and cause noise.

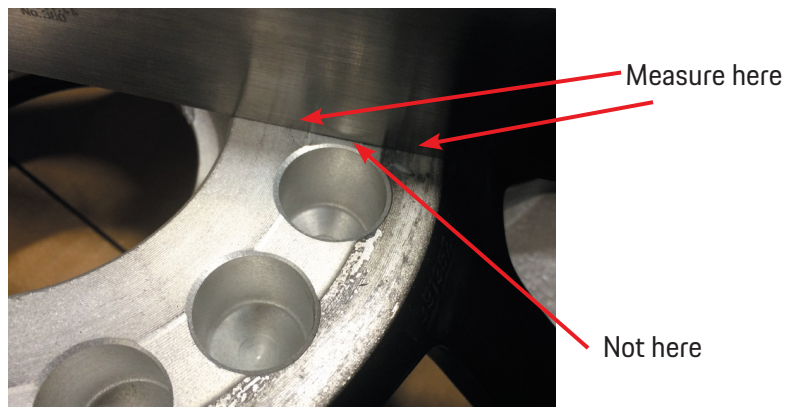
It is necessary to check for flatness in about 6 different positions around the mating surface (roughly every 60°), it is ok to do more than that, but not less.

The mating surfaces at the outer and inner areas of the mounting circle need to be checked for flatness. The recessed area in between (photo below) is not a part of the measurement.

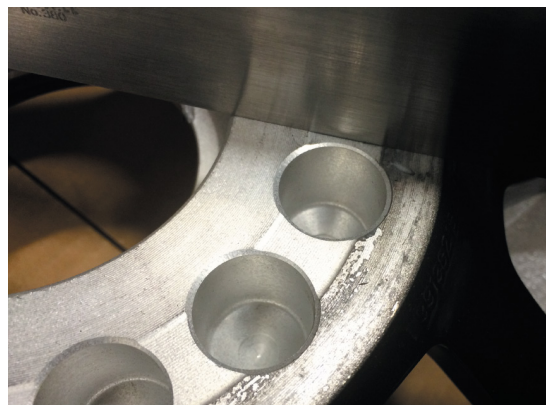
Use a feeler gauge that is very thin. The .05mm thickness is probably going to be necessary to find the uneven areas.
