**Y1A Charging Interrupts with Delta Wallbox Chargers**

Models	Model Year	Model Type	VIN Range	Vehicle-Specific Equipment
Taycan	2020	Y1A	N/A	N/A

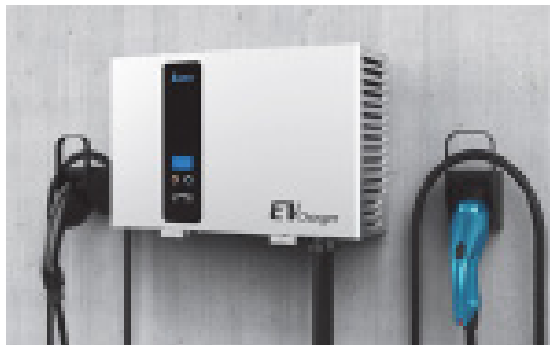
During charging sessions on Delta DC Wallbox EV Charger, interruptions may occur at different vehicle state of charge.

Due to a software issue in the Delta DC Wallbox EV Charger, a communication request from the vehicle may not correctly be answered by the charger. This may result in the vehicle ending the charging process prior to reaching the desired state of charge.

If a Taycan experiences an interrupted charging session on a Delta DC Wallbox EV Charger, the charging session may be manually restarted. No repairs on a Taycan should be attempted at this time.

Delta has developed a firmware update for the Delta DC Wallbox EV Charger that resolves this issue.
