Noise Symptom - Squeaking While Steering: Checking Installation Position of Dust Boot on Steering System (SY 103/19)

Revision:	This bulletin replaces bulletin Group 4 103/19, dated February 25, 2020.
Model Year:	As of 2020 up to 2021
Model Line:	911 Carrera (992)
Subject:	Power-steering gear
Symptom:	A squeaking noise can be heard from the power-steering gear area or from the steering column while steering.
Cause:	The dust boot on the power-steering gear may have been pressed in too far during production and as a result, it may rub against the power-steering gear housing while steering.
Remedial Action:	In the event of a customer complaint, check the installation position of the dust boot and replace steering gear if necessary.

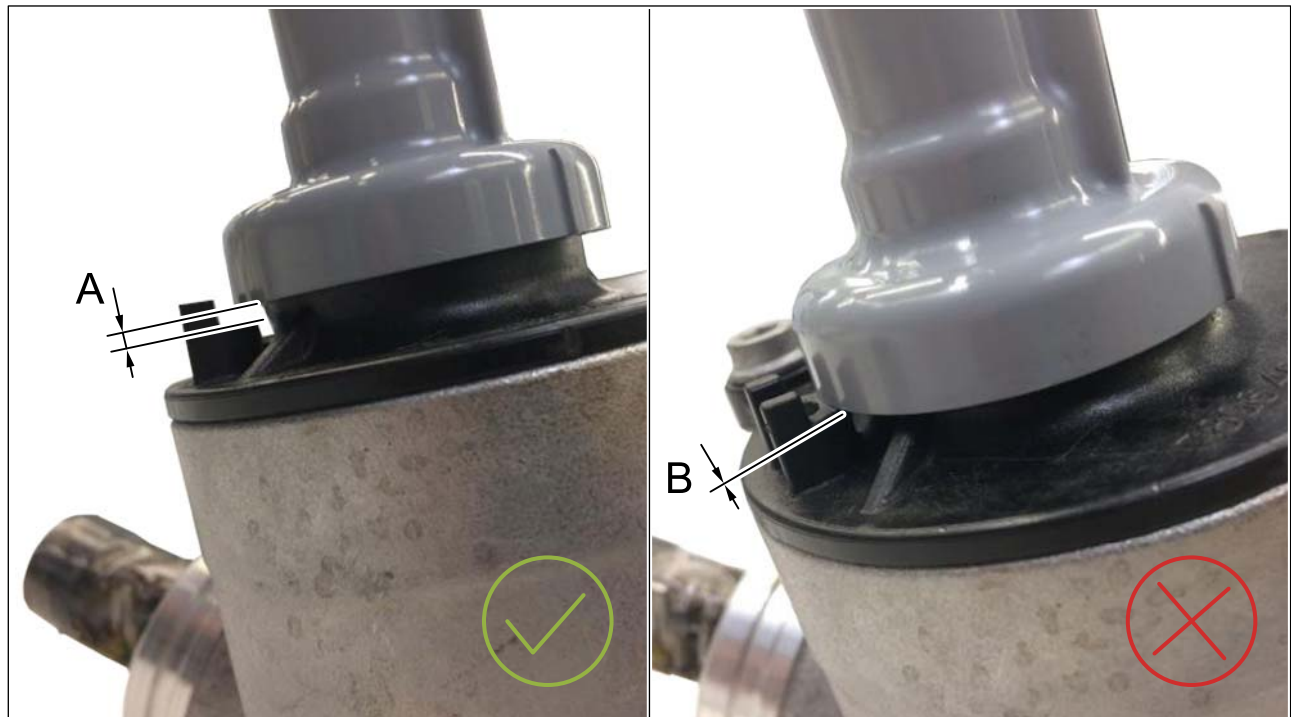
Checking dust boot

1.1 **If the gap is OK (⇒ *Checking dust boot -Dimension A-*):**

The dust boot is not the cause of the squeaking noise — Install front-axle support, see ⇒ *Workshop Manual '400819 Removing and installing front-axle support'*. Continue with fault finding.

1.2 **If the gap is not OK (⇒ *Checking dust boot -Dimension B-*):**

Dimension A – ~ 2 mm

Dimension B – ~ 0 mm

The dust boot is the cause of the squeaking noise — replace power-steering gear, see ⇒ *Workshop Manual '489019 Removing and installing power-steering gear'*.
