Squeaking / Creaking from Seat Back Cover

Models	Model Year	Model Type	VIN Range	Vehicle-Specific Equipment
Cayenne	2019 - Present	9YA/ 9YB	N/A	N/A

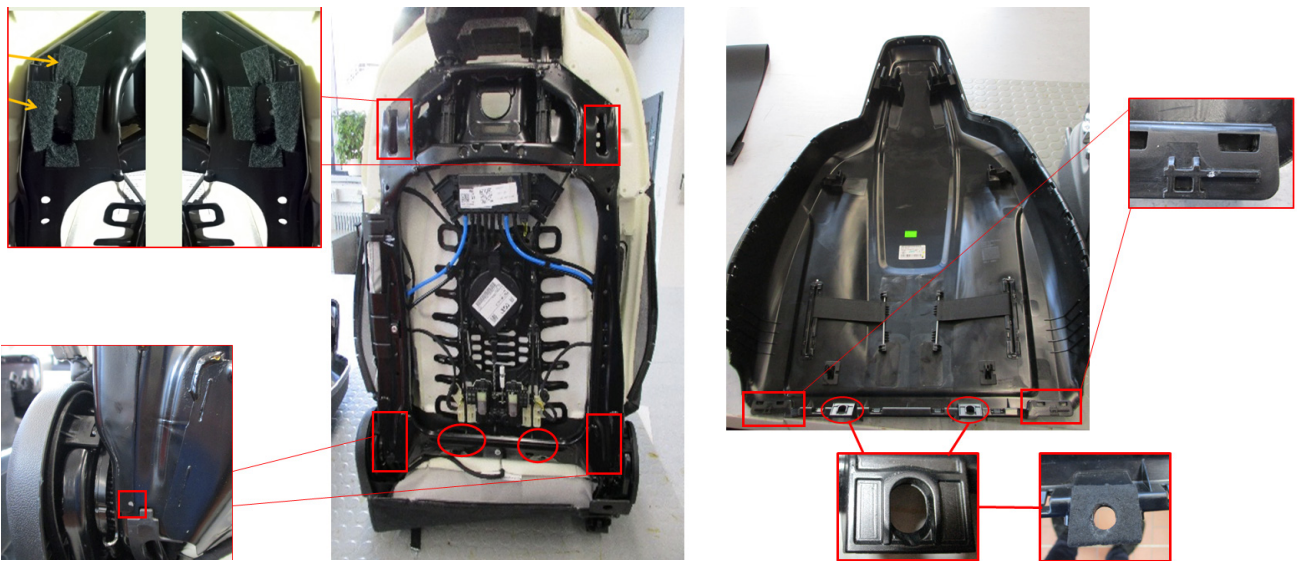
Contact between the plastic seat back cover and metal frame makes noise as a result of the stick-slip effect. Insulating the contact points with felt will remedy the noise.

1. The first pair is around the large holes at the top of the seat back frame.
2. The bottom of the seat back cover has two tabs in the center area that attach to metal tabs on the lower bar.
3. There are two contact areas at the bottom outer area of the seat back cover that also need insulating.

Use felt tape to insulate three pairs of contact points

The two large holes at the top of the seat frame have been insulated in production, as shown in the photos, since 10-27-2020. The other points have not been insulated in production at this time.
