117/19 ENU 9035

Symptom in Vehicle Interior - Clicking Noises During Outgoing Call When Seat Heating is Active: Reworking Wire Harness (SY 117/19)

Revision: This bulletin replaces bulletin Group 9 SY 117/19, dated January 10, 2020.

Model Line: Cayenne (9YA)

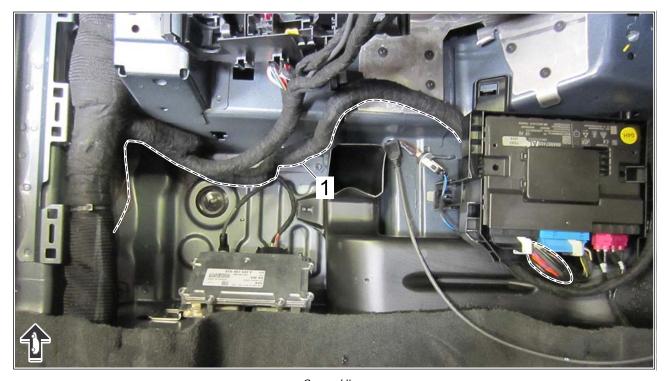
Ground line

Cause: The shared ground supply of the Connect control unit and front-end electronics control unit can cause

interference.

6 Route new ground line ⇒ *Ground line* -1- along the wire harness towards the Gateway control unit and Connect control unit and secure it with tie-wraps.
